# Why UltraShield®?

# UltraShield®

# UltraShield® Advanced Capped Composite Material

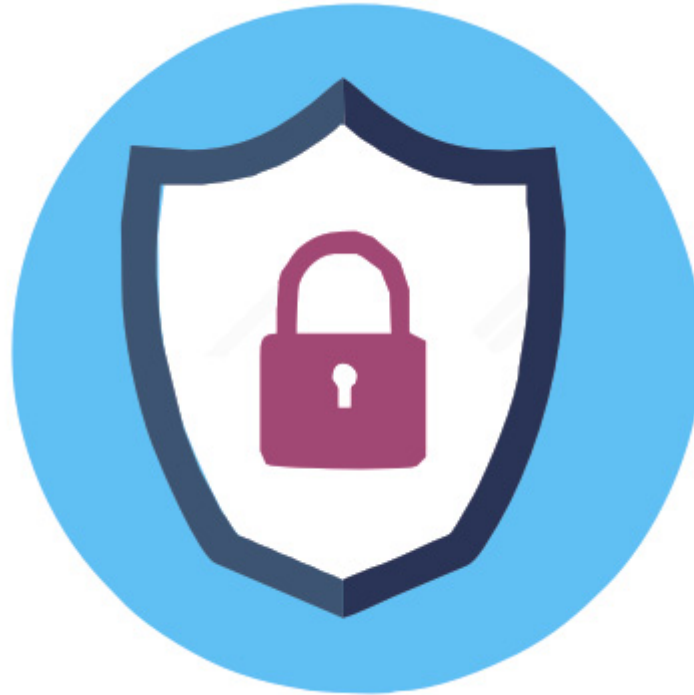
## To make the board capped 360 degree around :

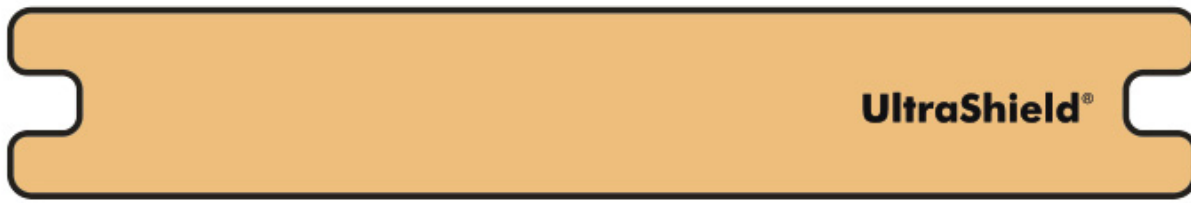
A cross-section of a composite board with a full protective cap on both ends. The text "UltraShield®" is printed on the right side.

A blue shield icon with "360°" inside, next to a green checkmark, indicating full protection.
B

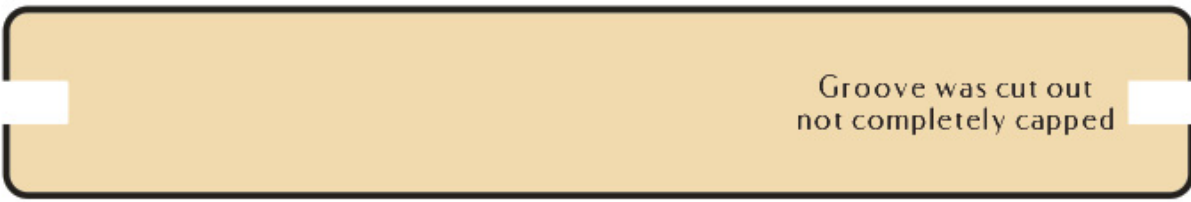
A cross-section of a composite board with a groove cut out from the end cap. The text "Groove was cut out not completely capped" is printed on the right side.

A shield icon with the word "cut" inside, next to a yellow warning triangle, indicating a vulnerability.
C

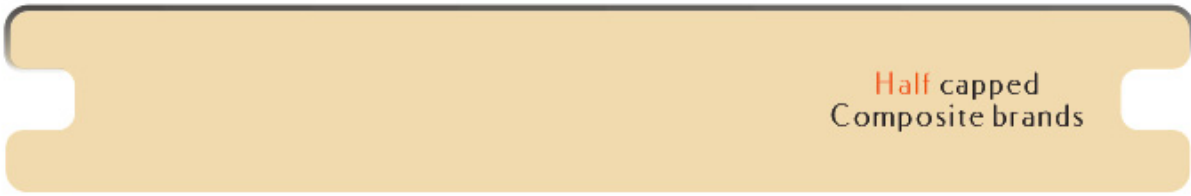
A cross-section of a composite board with half-capped ends. The text "Half capped Composite brands" is printed on the right side.

A shield icon with "1/2" inside, next to a yellow warning triangle, indicating partial protection.
D

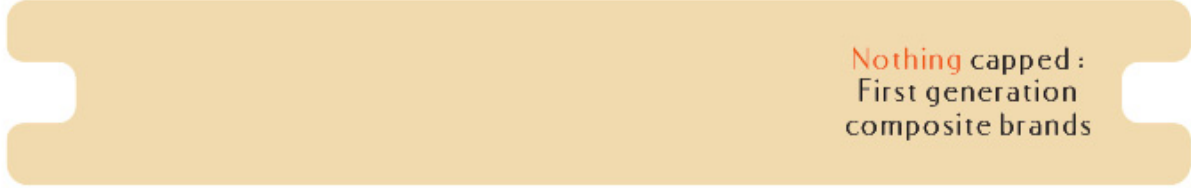
A cross-section of a composite board with no protective capping. The text "Nothing capped: First generation composite brands" is printed on the right side.

A shield icon with "0" inside, next to a red 'X' mark, indicating no protection.

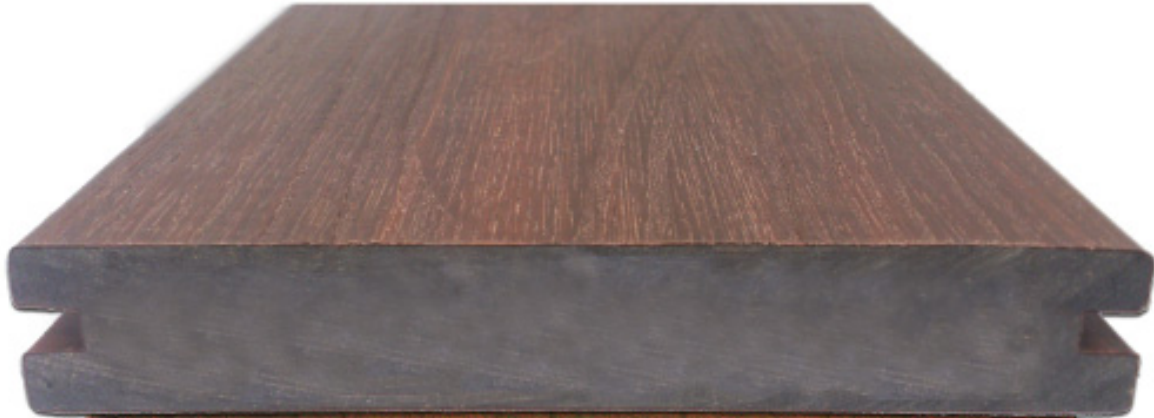
A

**UltraShield®**

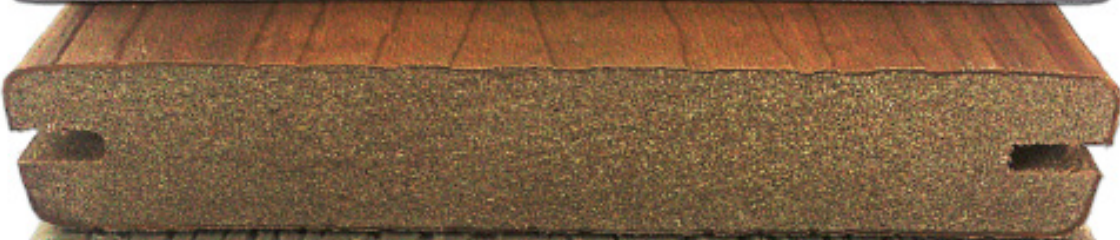
B

Groove was cut out  
not completely capped

**Some brands have boards with uncapped groove, by cutting out the groove on both sides of the board, or were unable capped technically.**

- With uncapped groove, the moisture can still go into the core from the groove along the entire board, so the swelling, cupping and cracking hazards are still potentially existing
- During the groove cutting, the capped layer could be damaged.

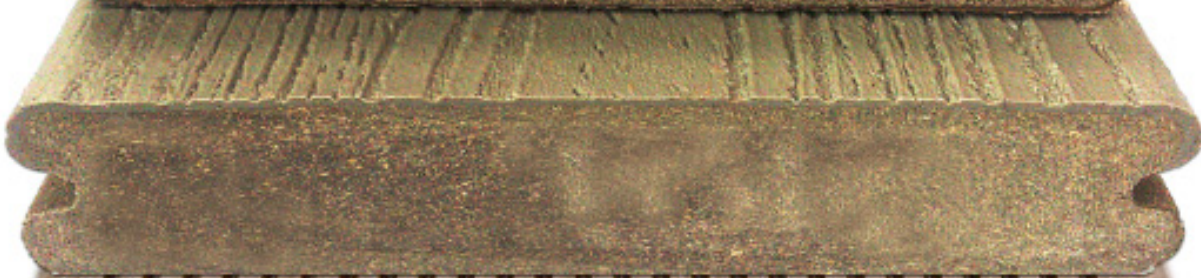
C

Half capped  
Composite brands

**A brand only capped top half of the board,  
this solves some problems, but other problems occur**

- Capping the top half of the board does provides higher stain & scratch resistant, and gives protection against UV from top so it helps to maintain the color in certain period of time.
- However, because the capped layer shield and inner core were made of different materials, so they have different expansion and contraction rate, and also more significantly in this case: the difference in water adsorption rate.

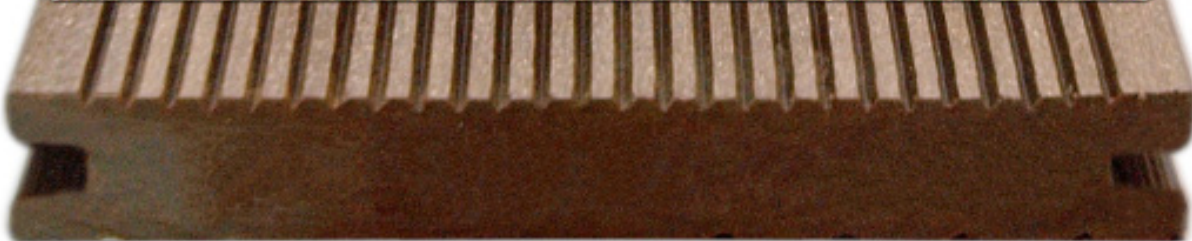
D

Nothing capped :  
First generation  
composite brands

**Composite boards without any coating, nothing capped around, known as first generation or conventional composite**

- Without any cap to protect the core, the wood fiber is exposed to the surface and damaged by various harsh weather condition, UV, moisture, and bacteria.
- Not only the color will be faded out, the structure and composition will be degraded or even destroyed. Many severe problems have already risen during the past few years in the wood composite market.

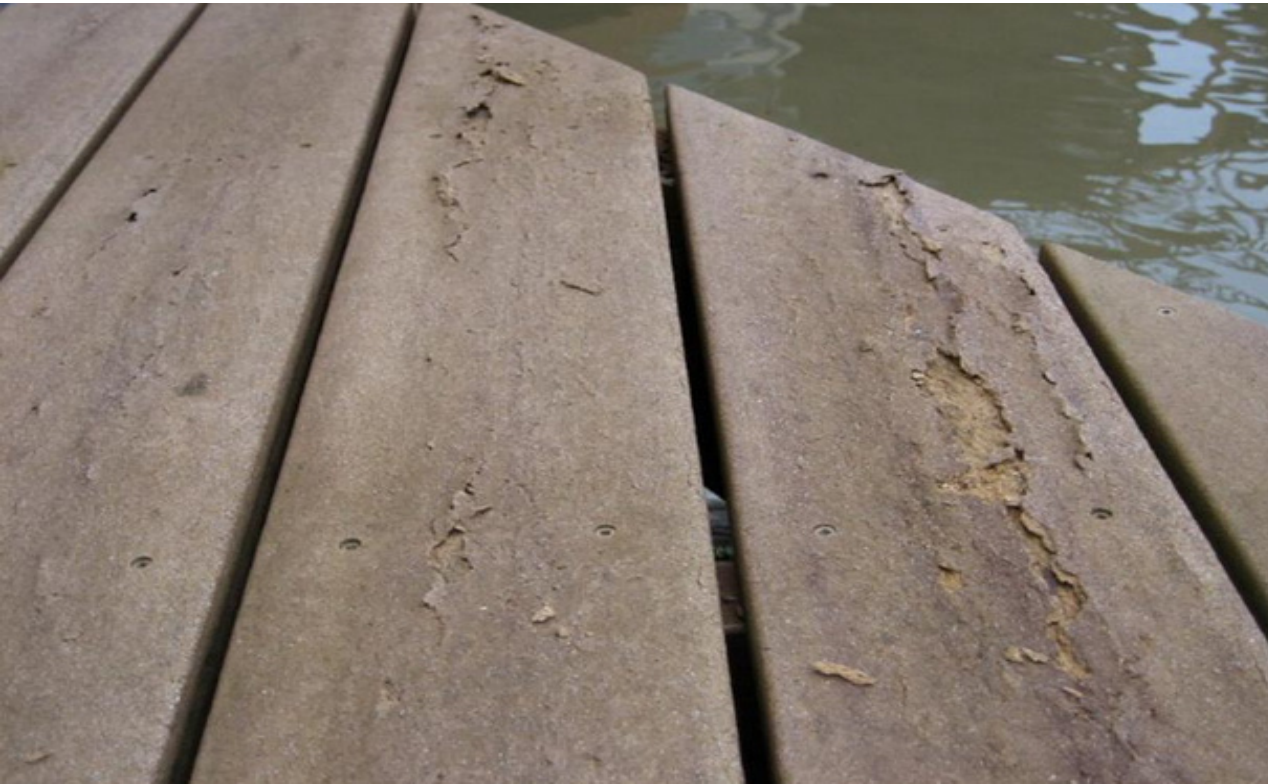
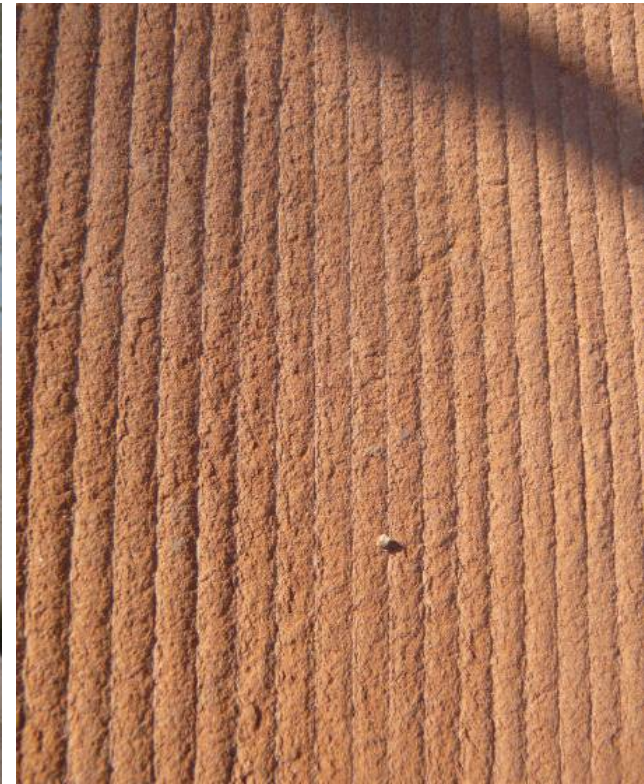
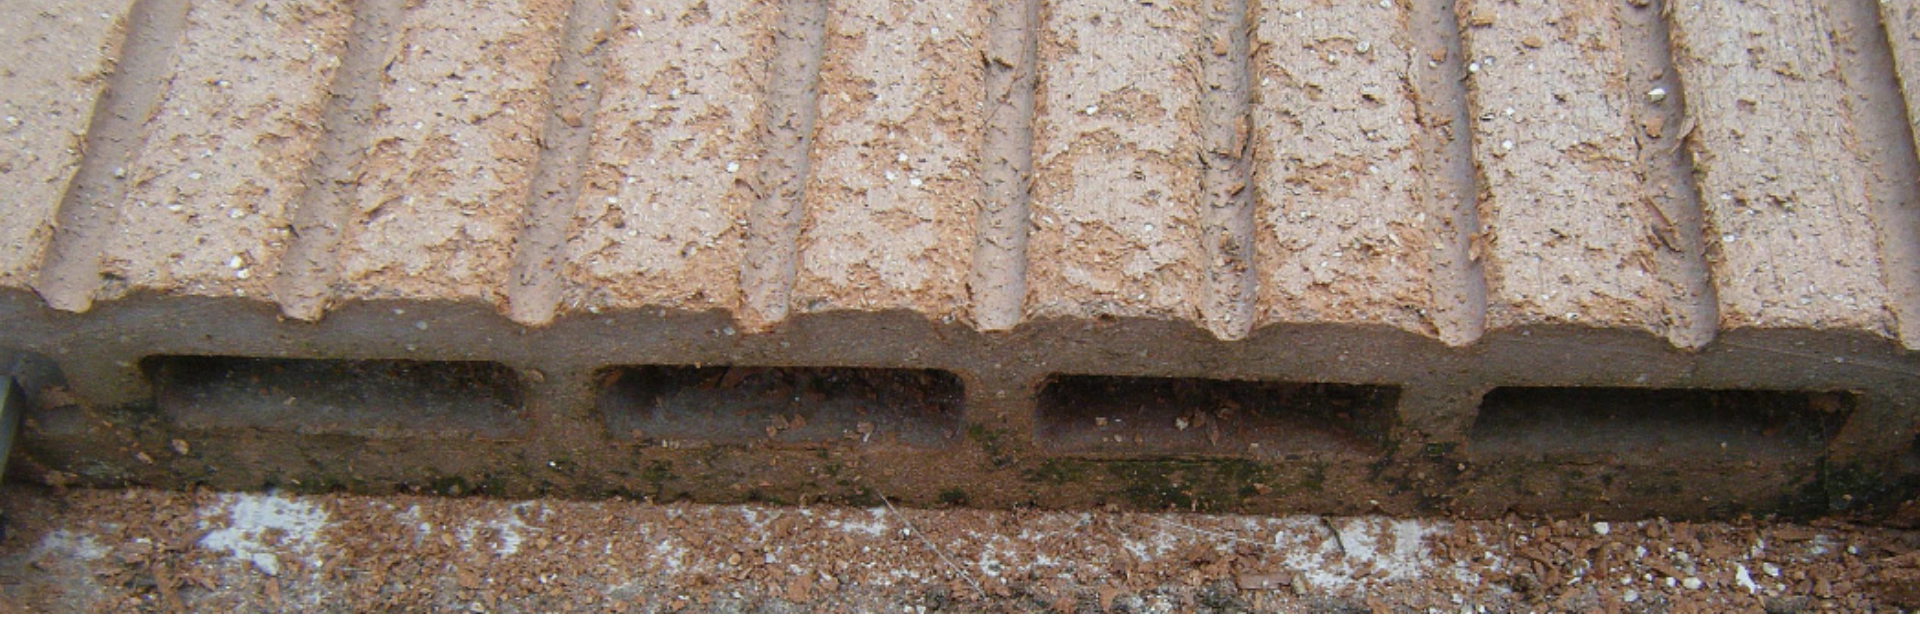
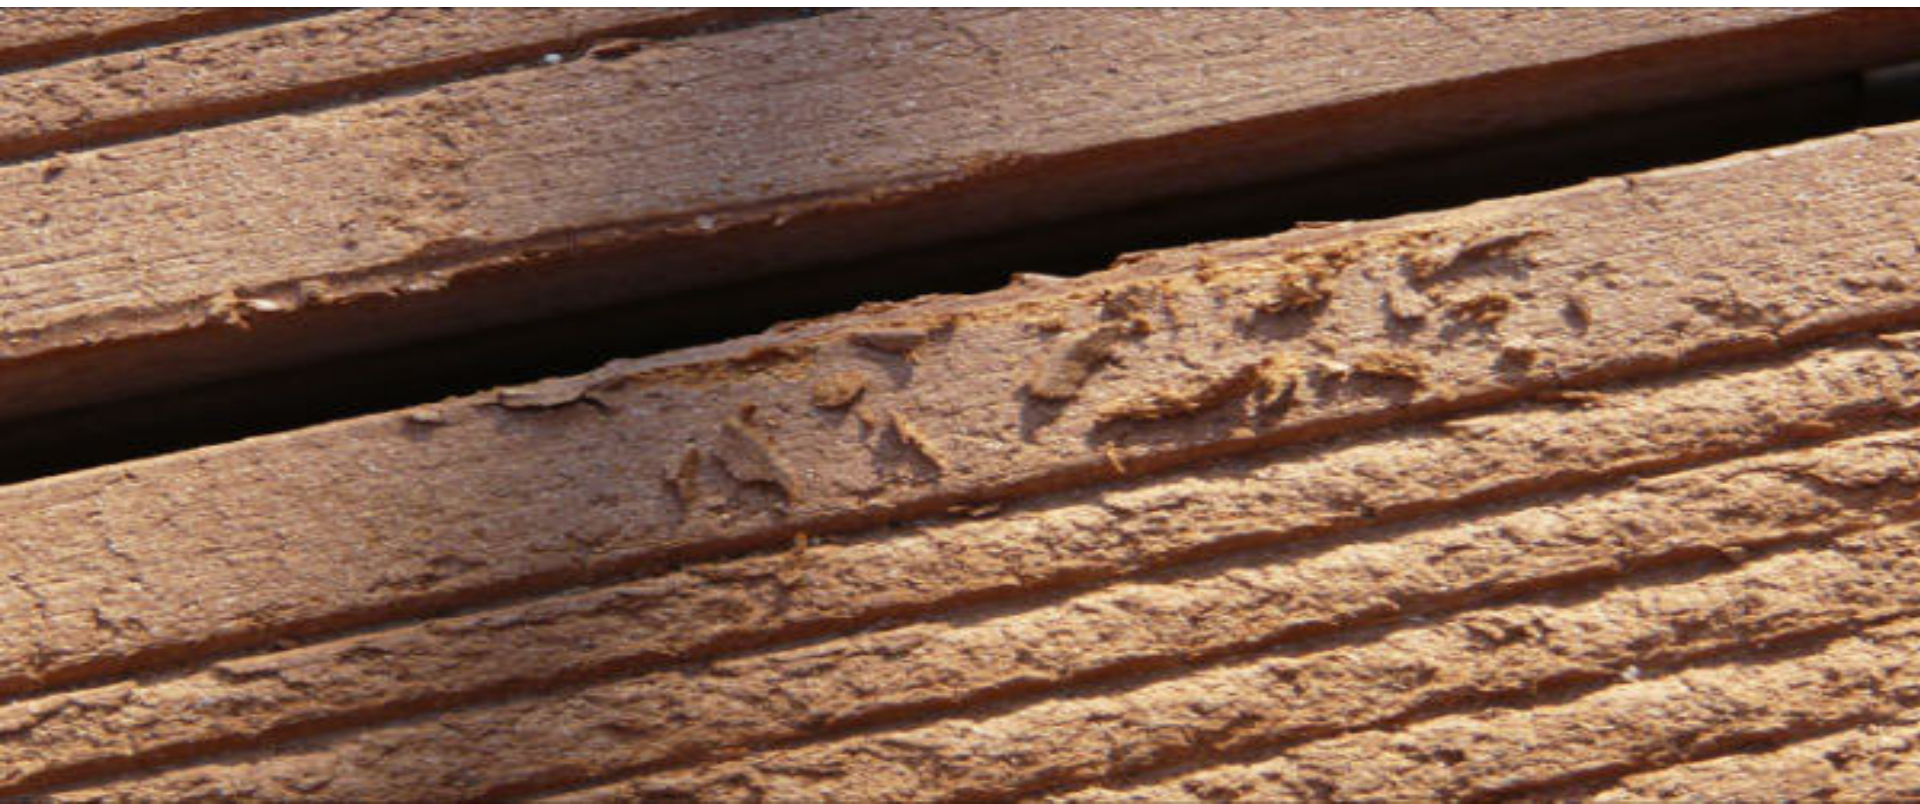
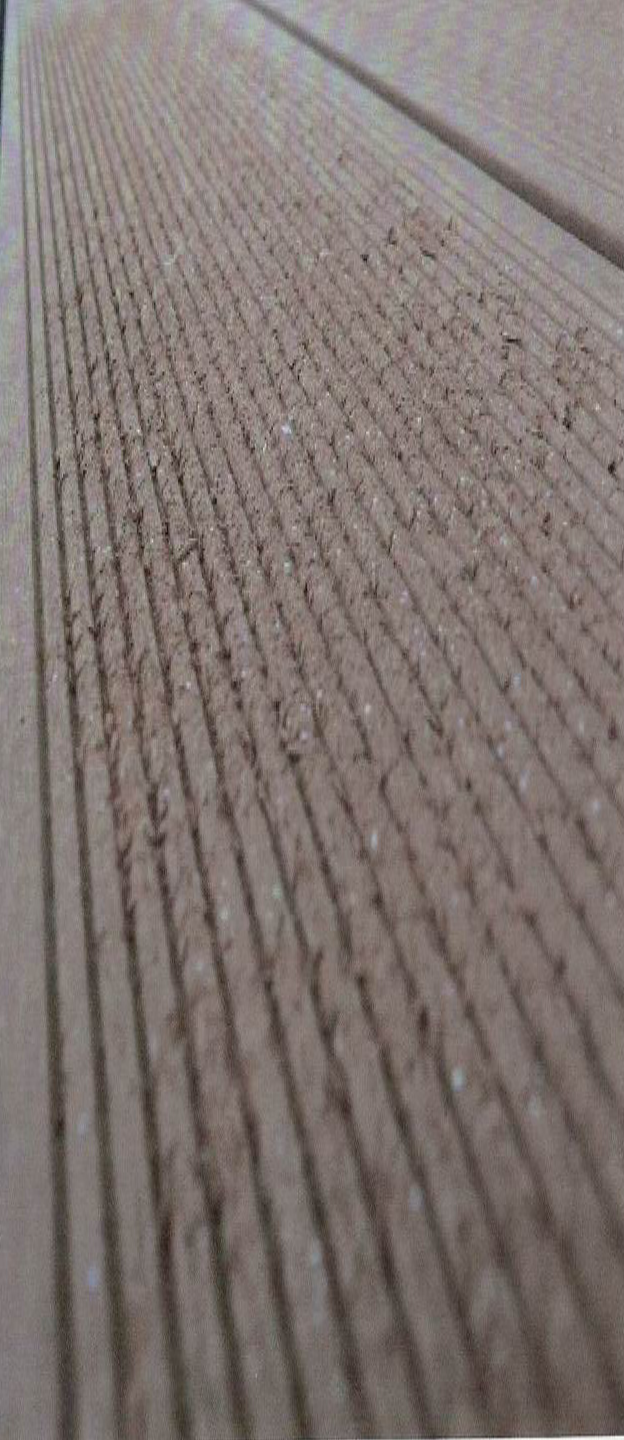
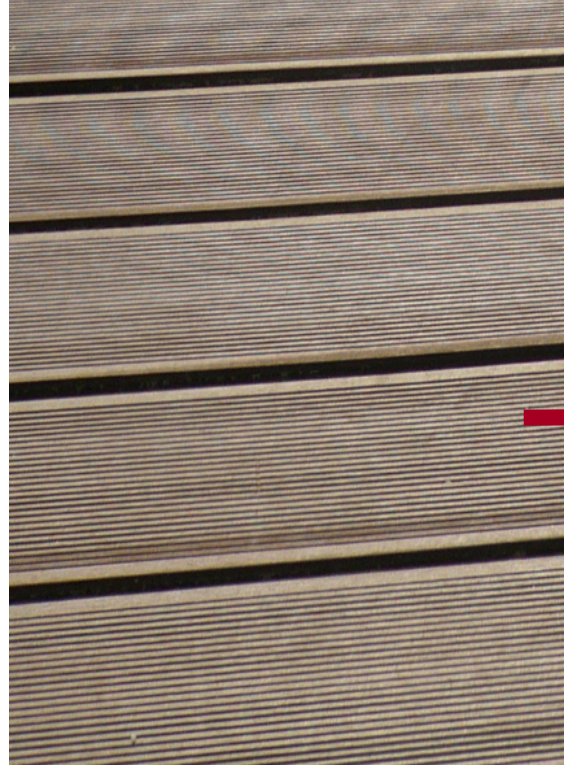
- When the first generation composite board expose to the UV and water, it begins to decompose and break down. This is due to an improper amount of bounding agent and antioxidant added to the first generation composite material.
- The wood fiber absorbs moisture with UV together which causes composite decking to decay, crumble, decompose, degenerate, deteriorate, disintegrate, and rot.

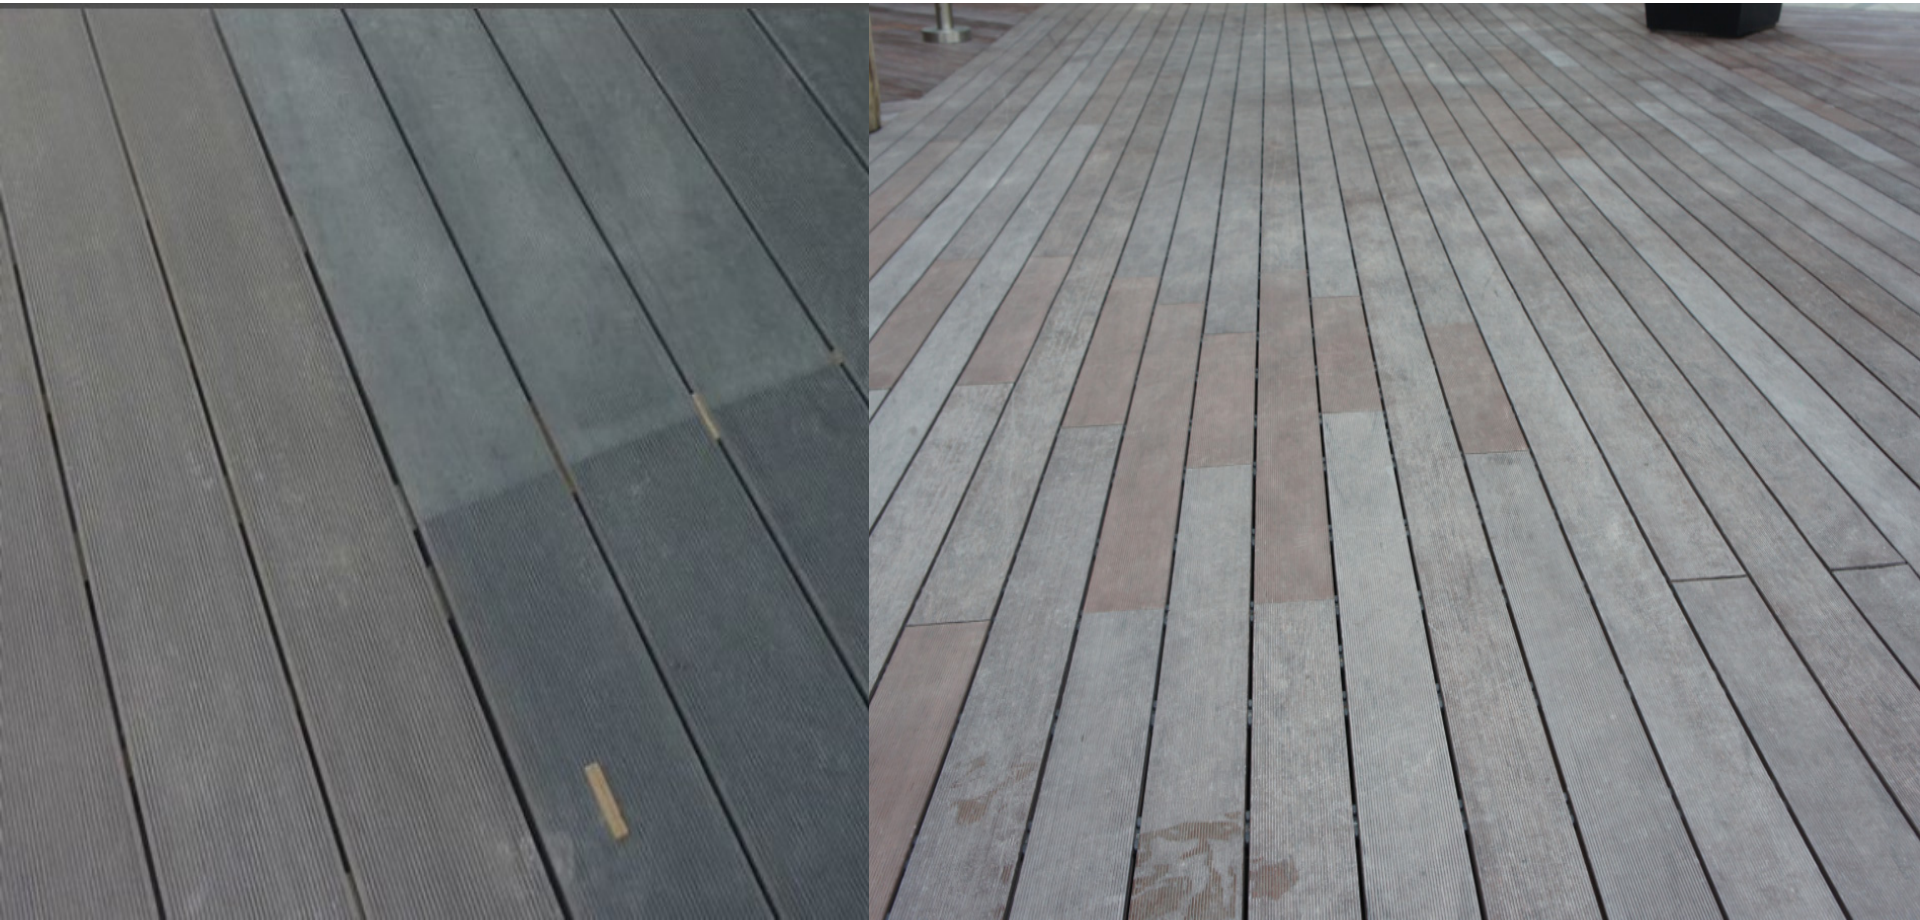
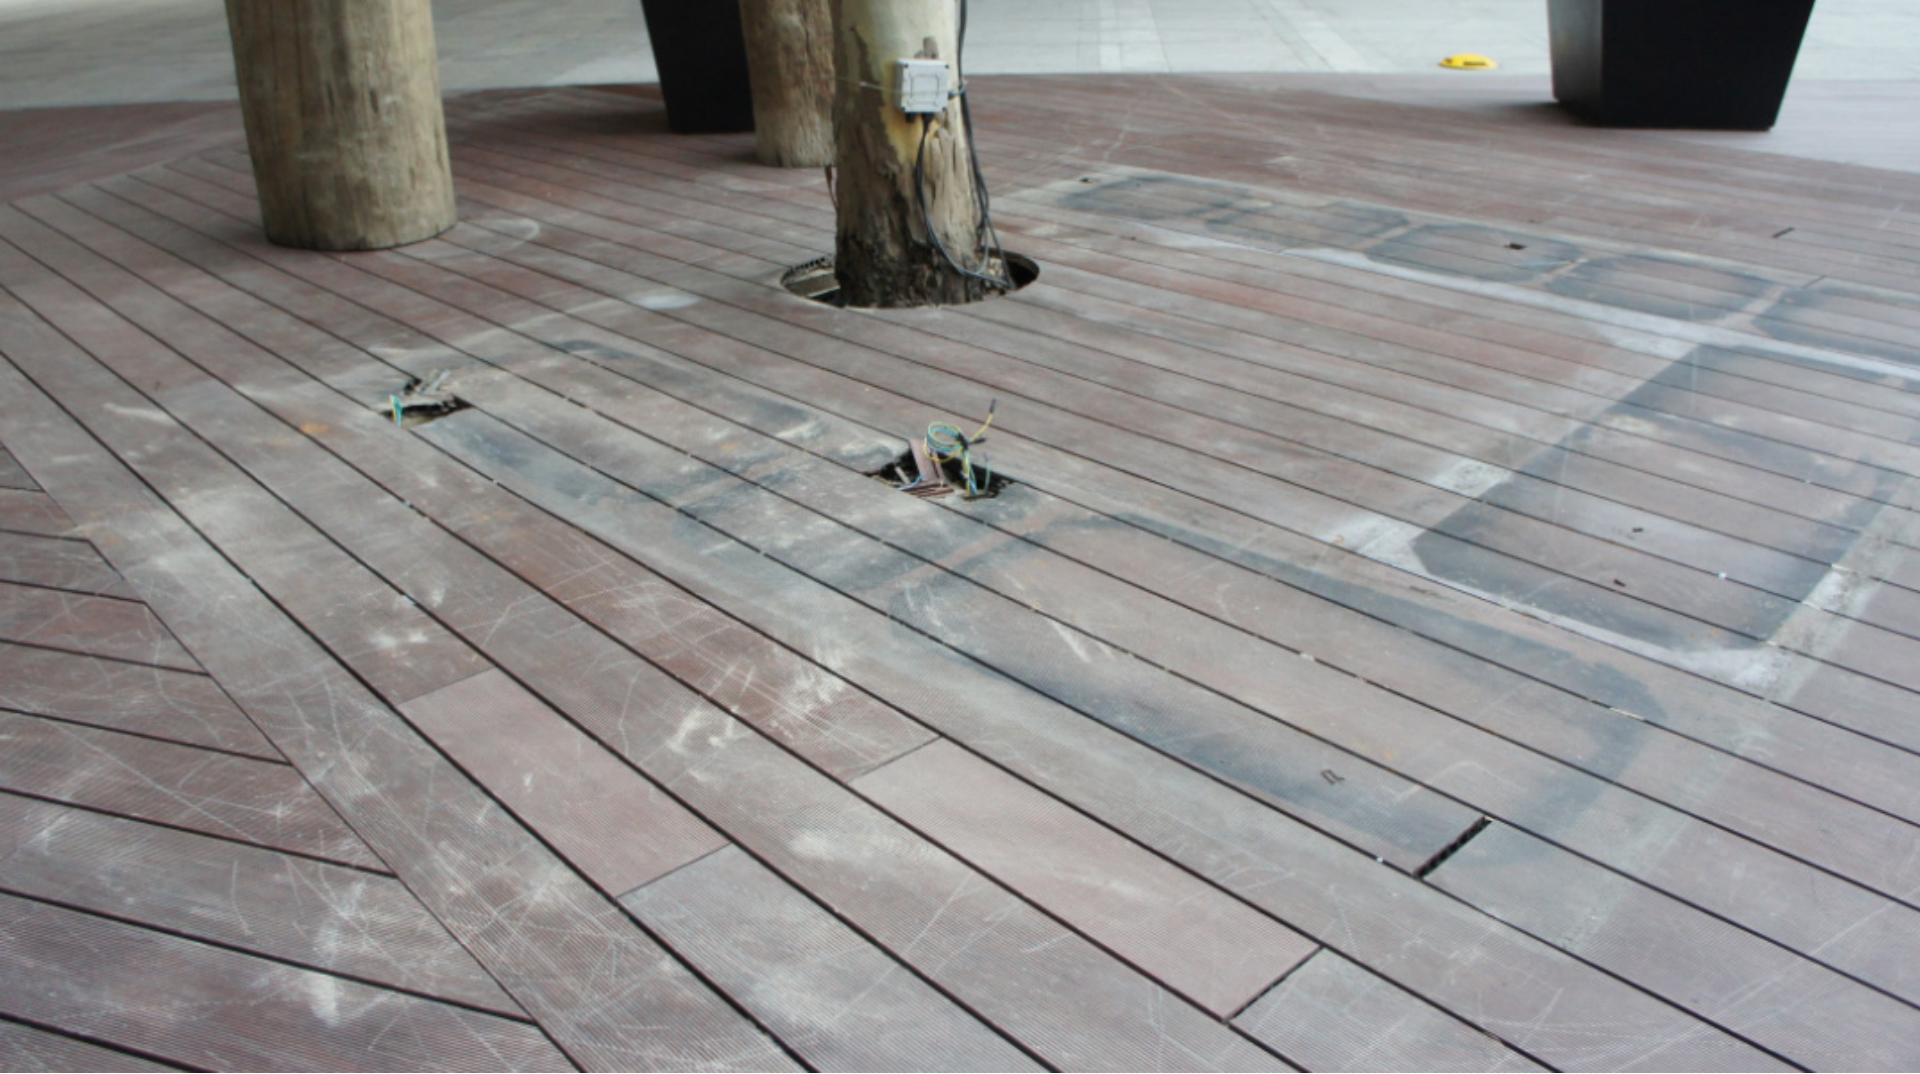
- Color fading has been a huge issue. The reason for the fading comes from the wood fiber content. Even when mixed with enough antioxidants and UV stabilizers it will still fade due to the nature of the wood fiber.
- What's even worse it is the fading level would hardly be the same.

Color difference-many decks were faded with uneven color resulting in some boards being lighter and others getting darker.

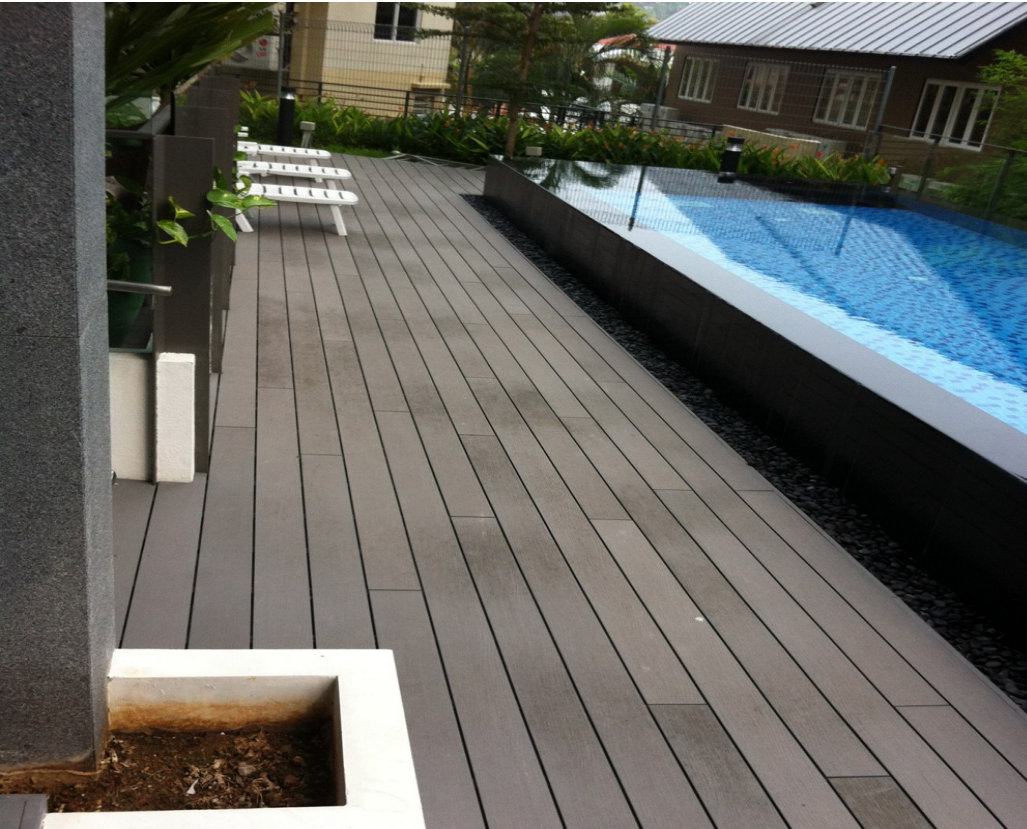
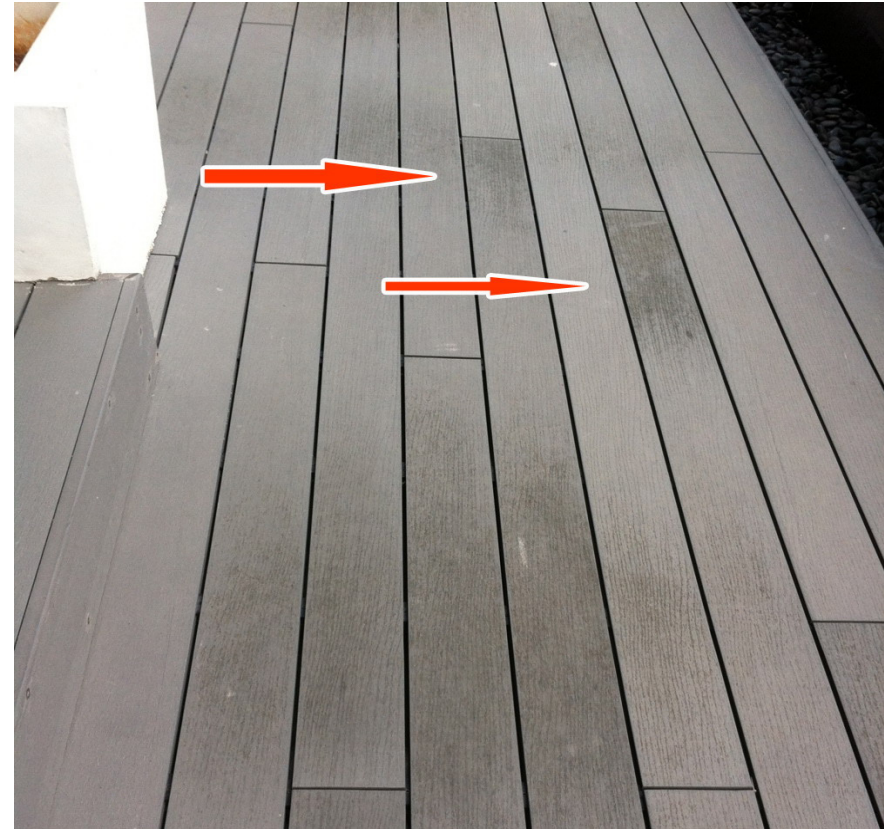
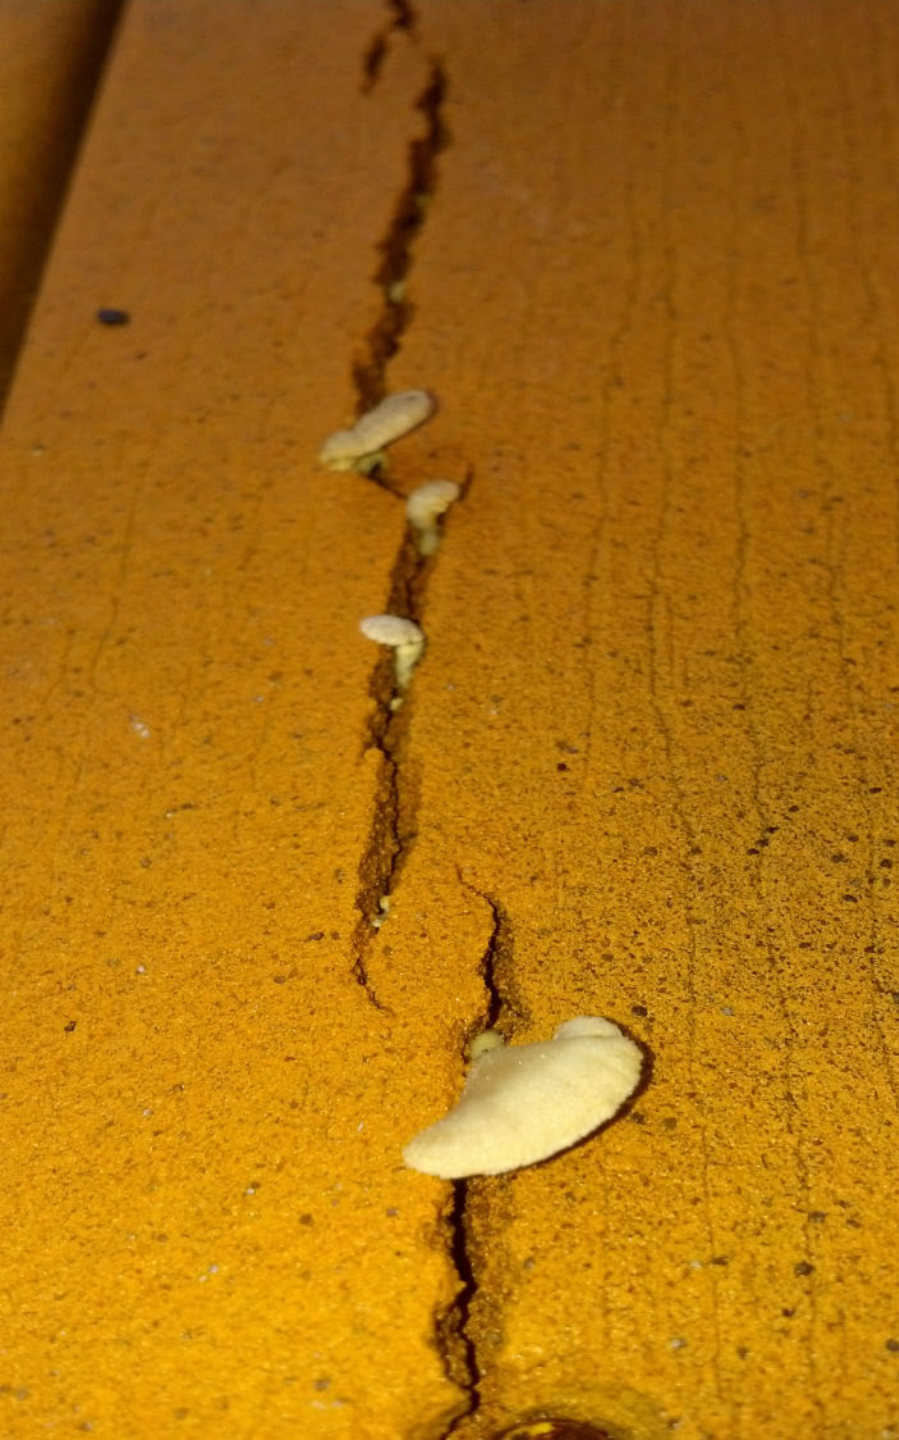
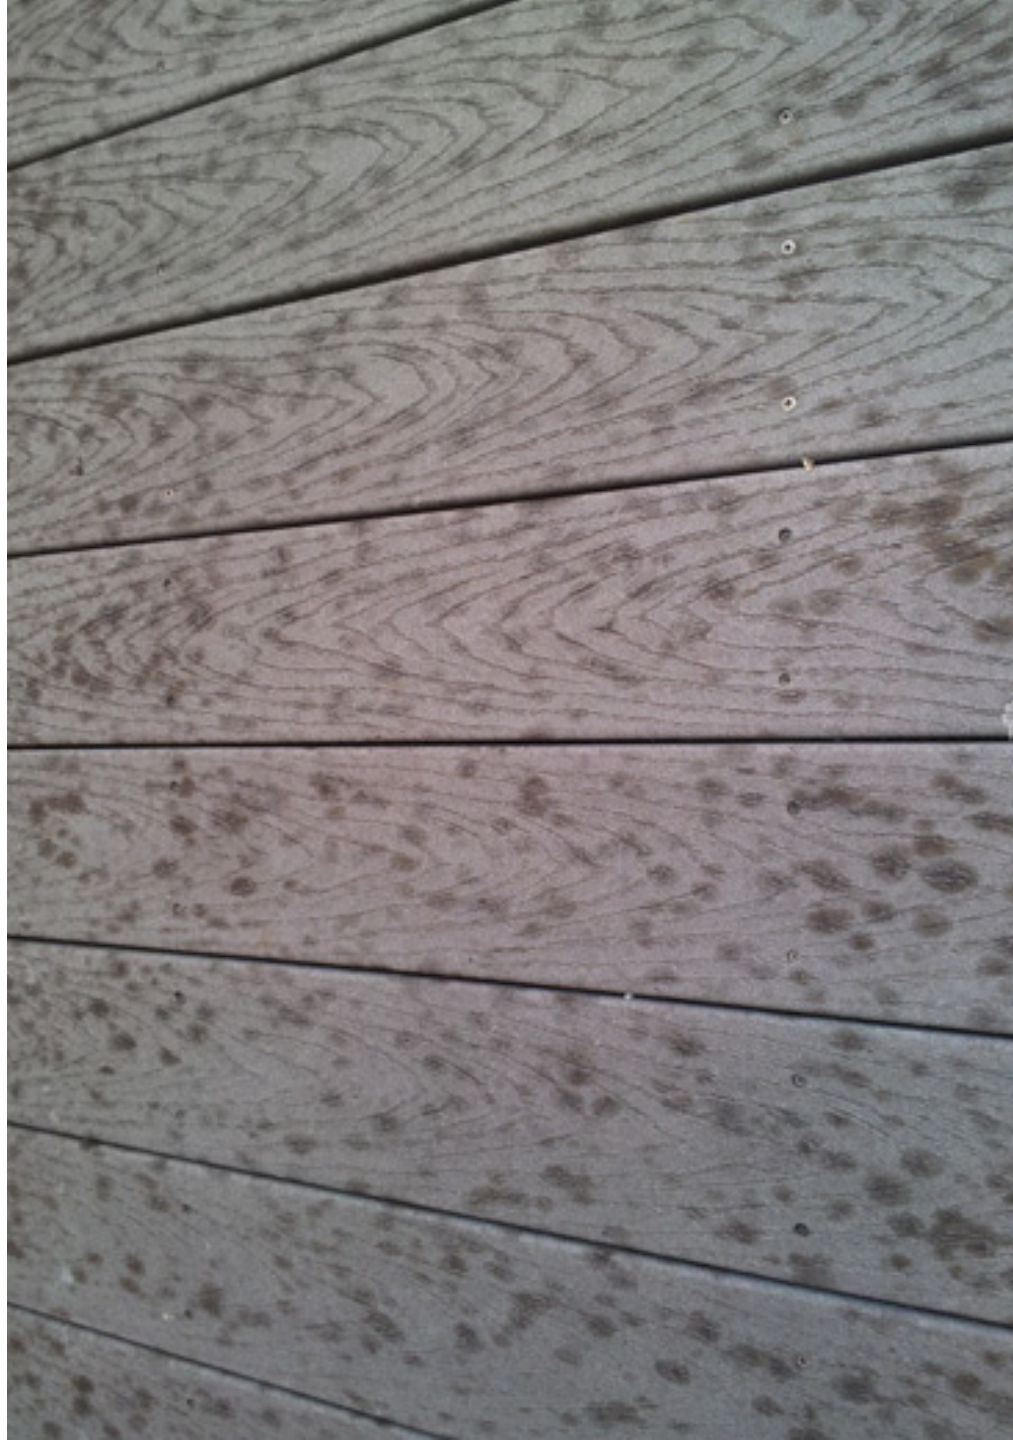
- This problem really has found in many places in U.S. because of extreme climate condition. Some of the places go through hot, cold and wet all in one day. Mold is actually attacking the exposed wood fibers on the surface of the board, creating black mold stain. Many people try to use deck cleaners to clean off the mold but it actually comes back many times worse than before.

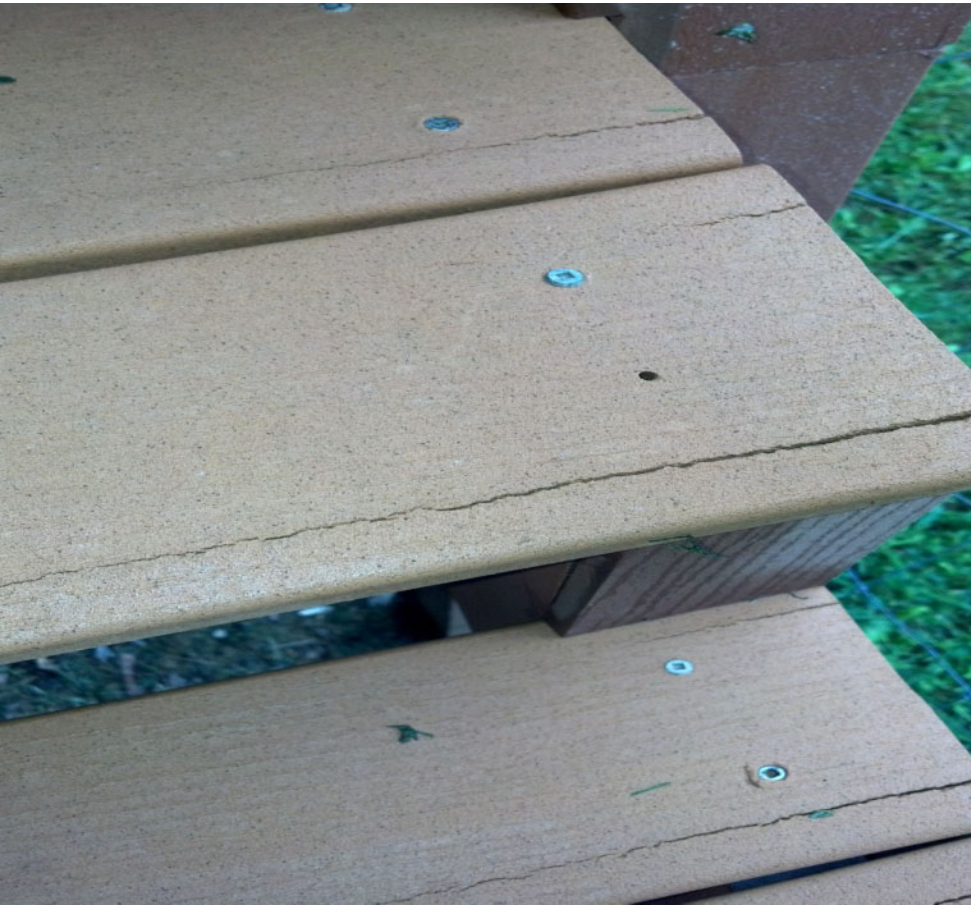
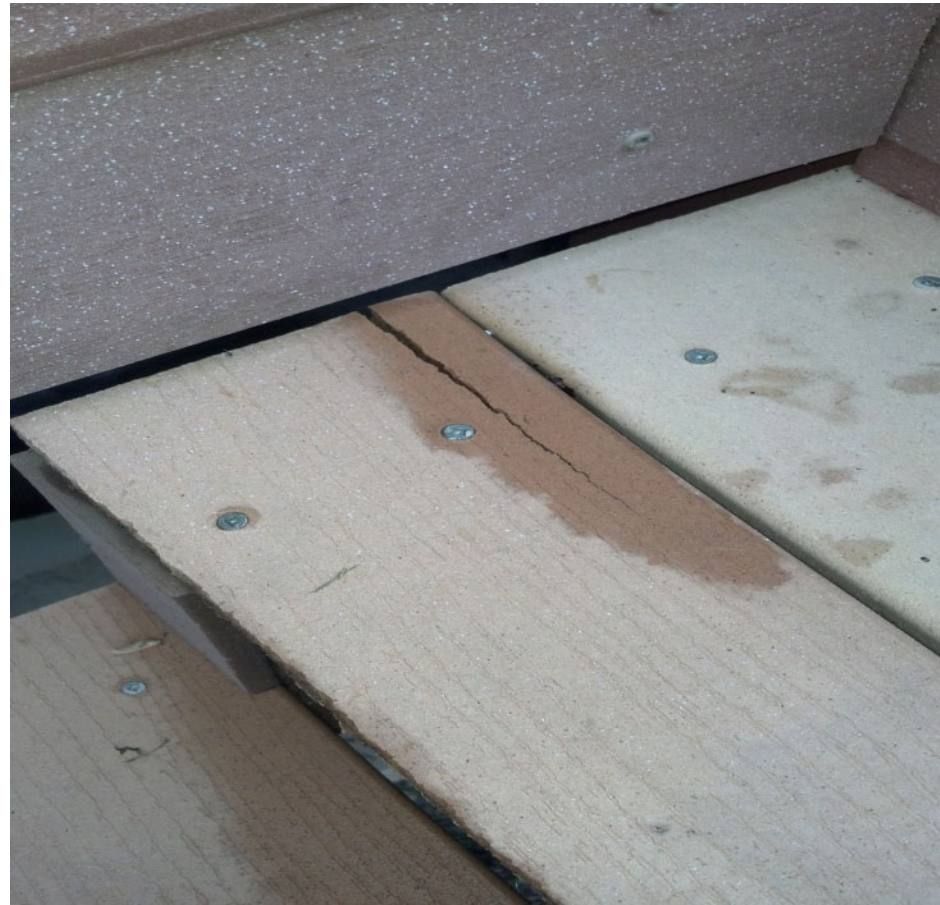
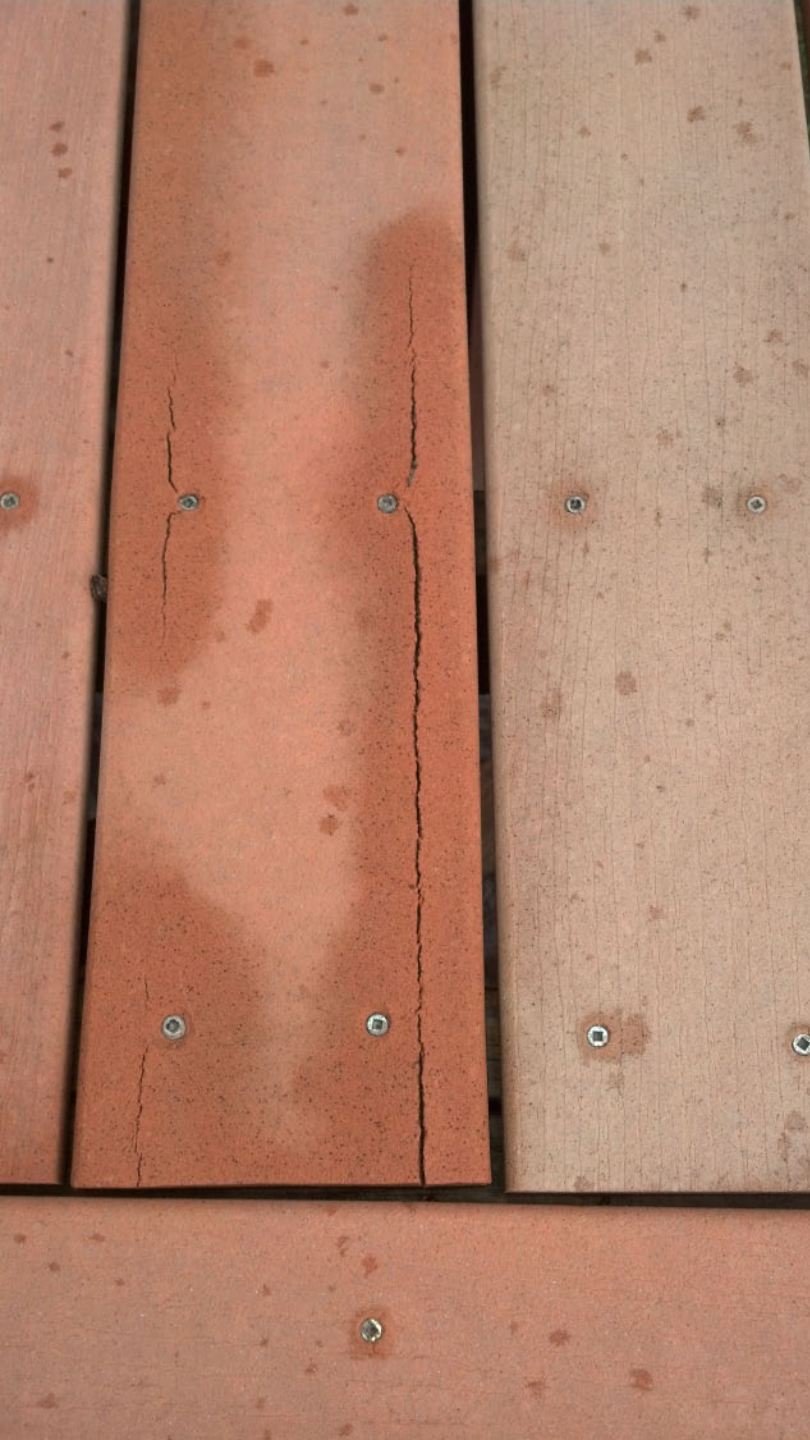
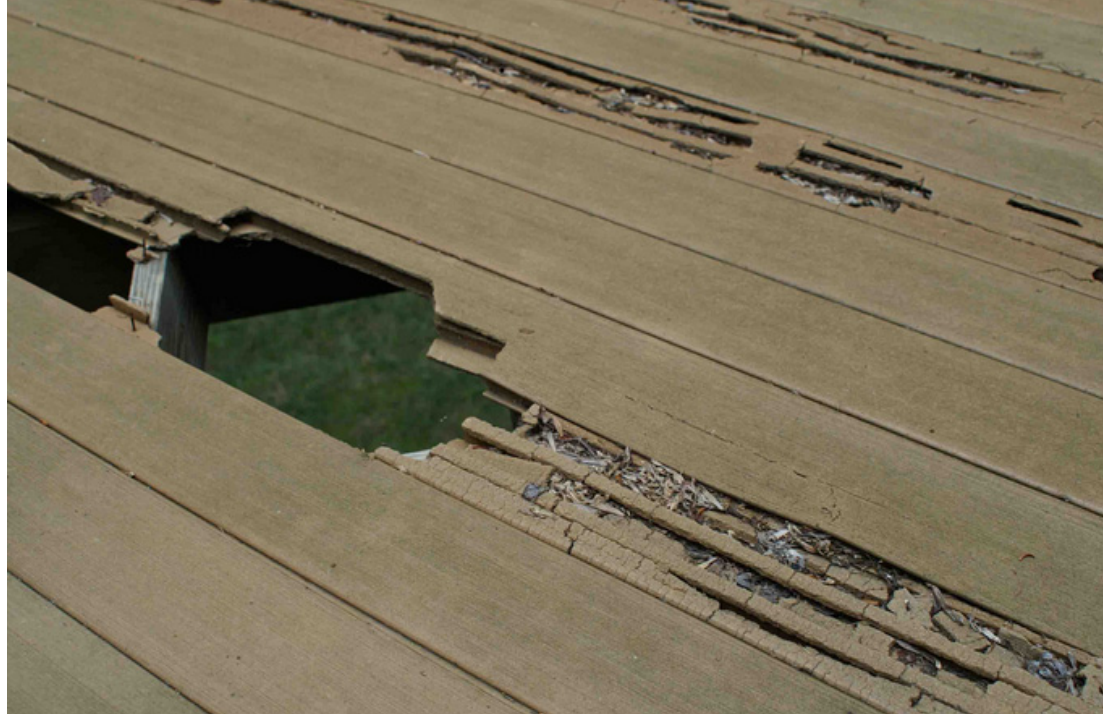
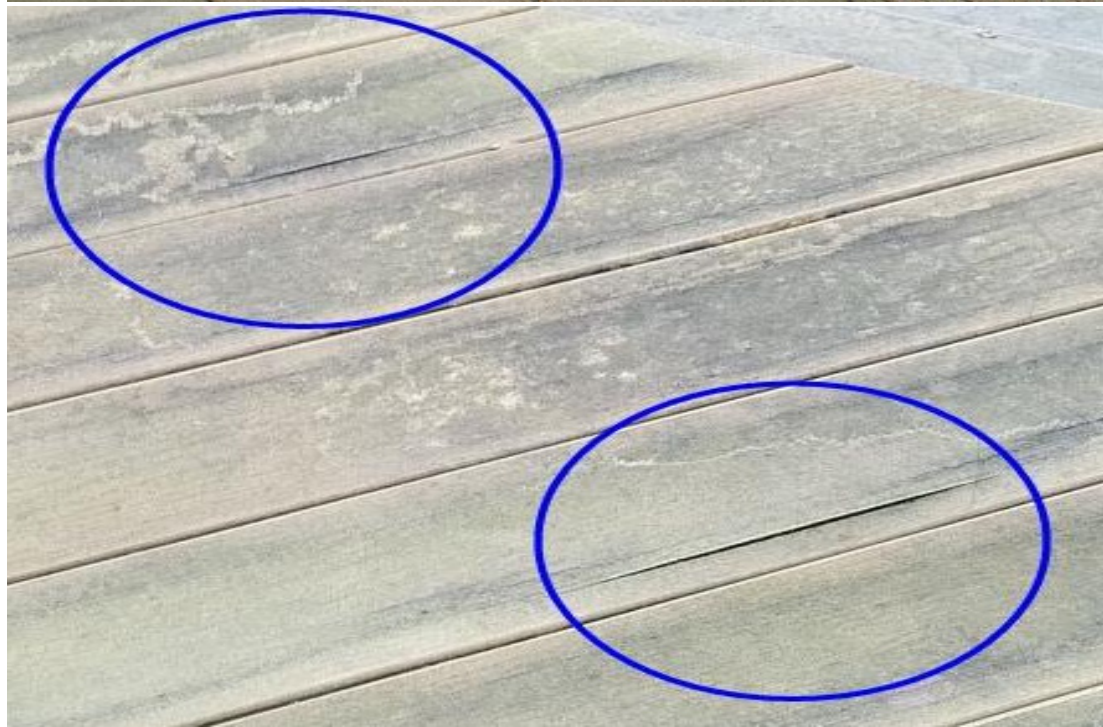
- Cracking is a break down of the composition of the board due to UV and Water. Some additives will help but eventually the exposed wood fiber of all first generation composite boards will deteriorate and the strength of the board will be weak and started cracking during the process of expansion and contraction. This is even more apparent around the area of screw and nail.
