# Why UltraShield®?

# UltraShield®

# UltraShield® Advanced Capped Composite Material

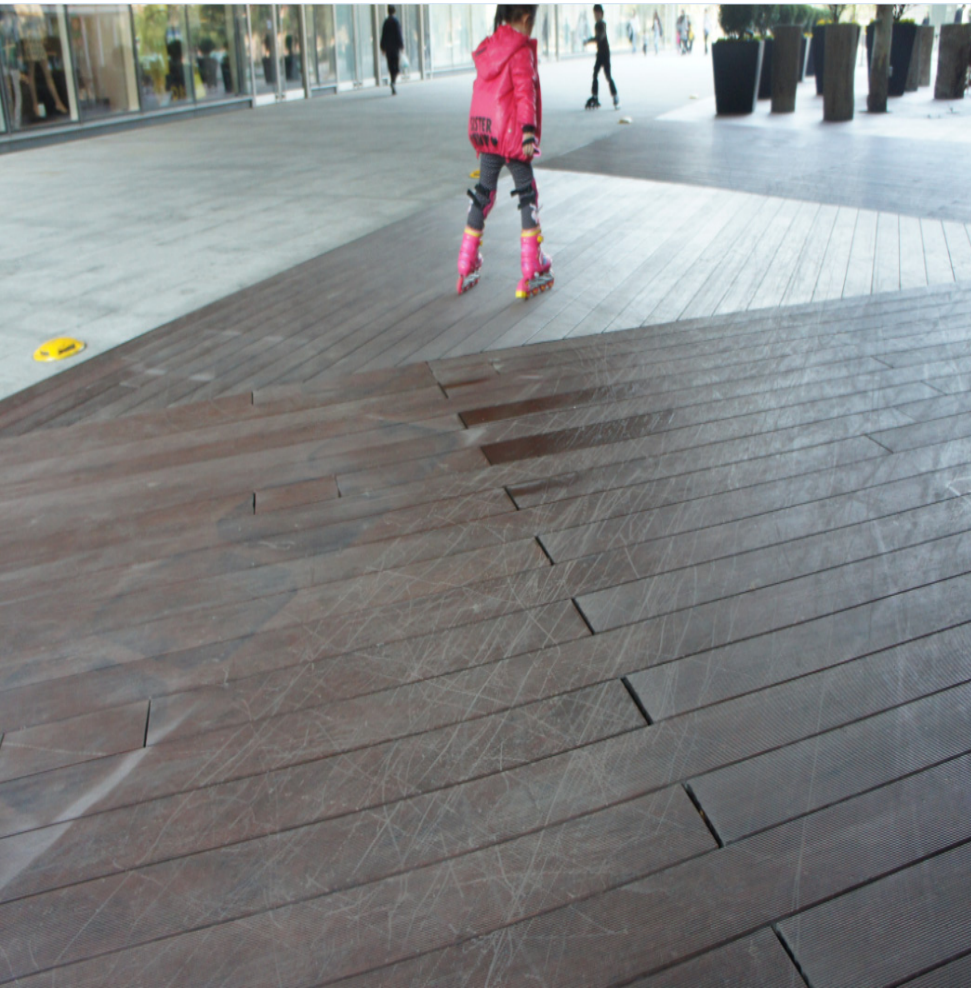
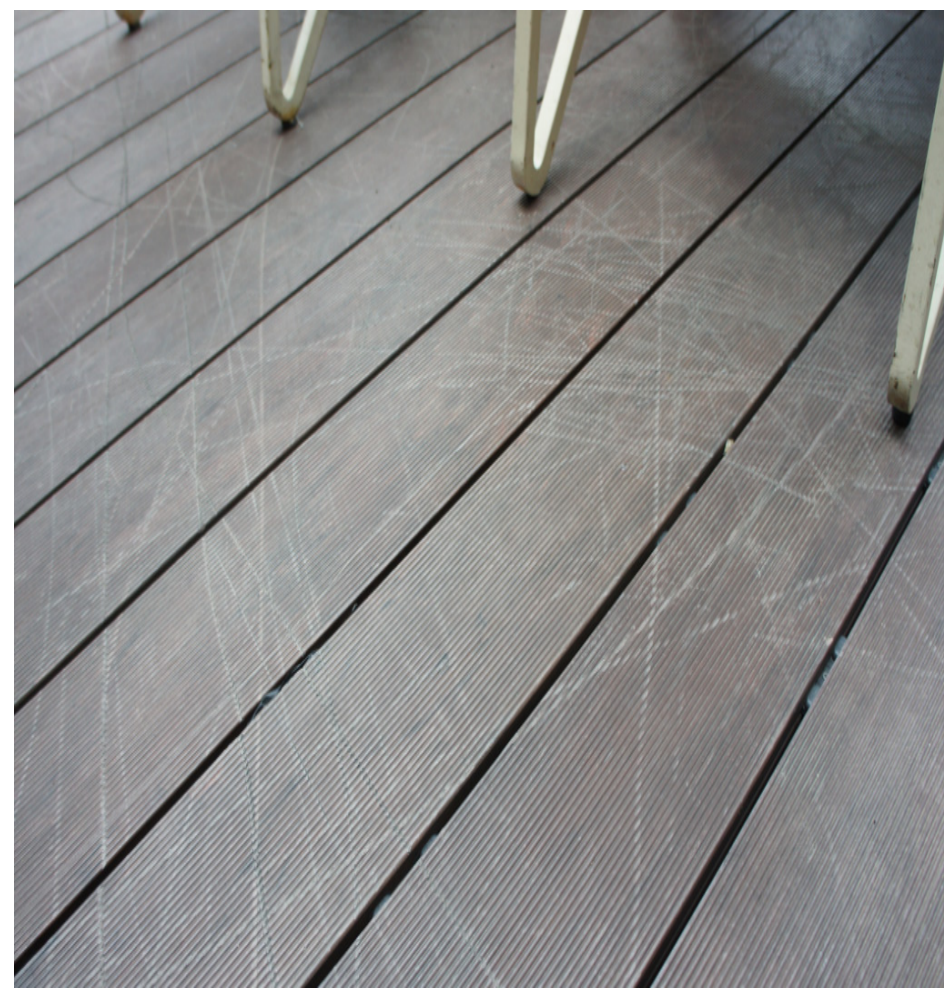
- Composite decking is not a completely scratch proof material. The difference between the first generation and the capped composite is that the surface is more scratch resistance. The first generation product will scratch with simply using a finger nail.

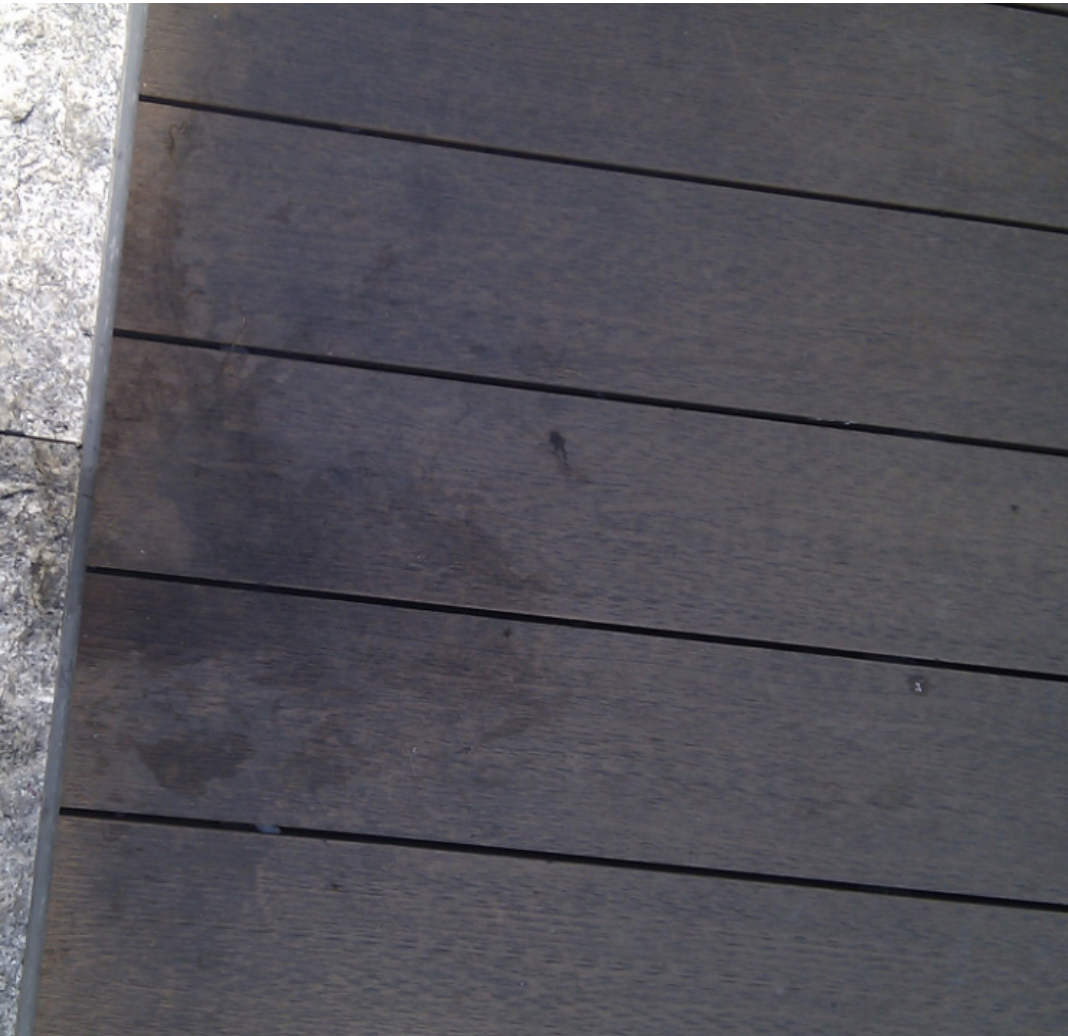
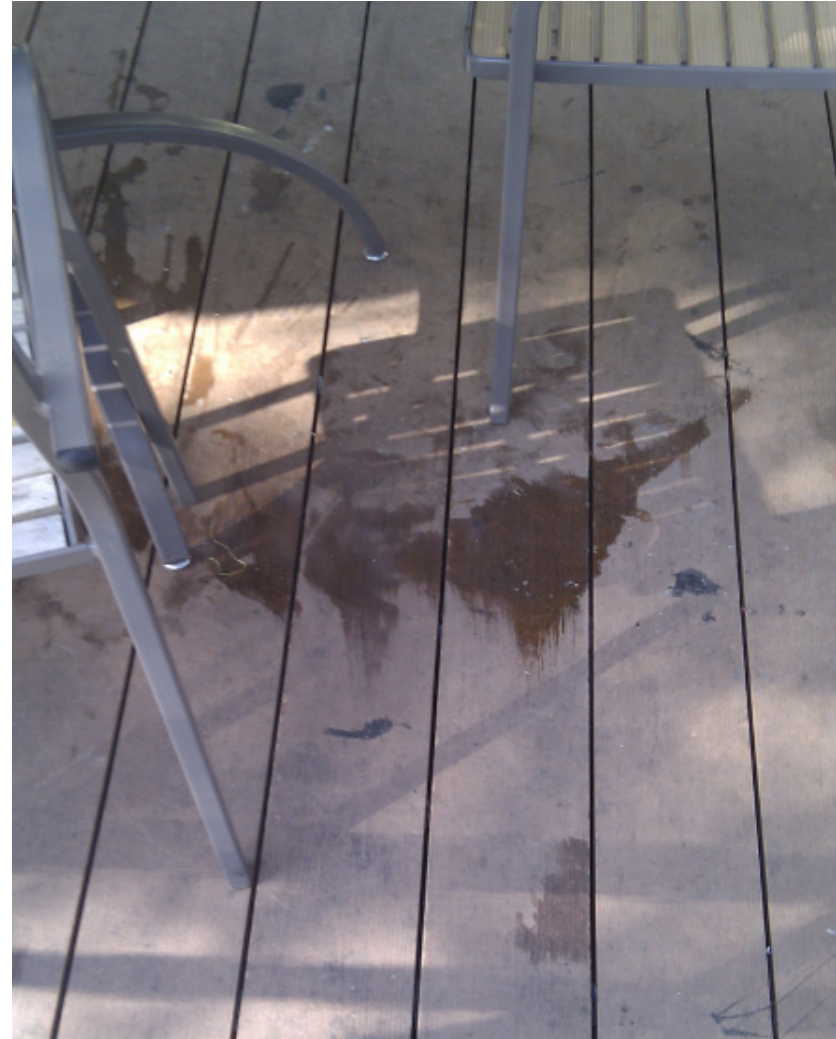
- Without any cap protection, any stains will be absorbed by the wood fiber or penetrate in between the wood fiber and polymer directly and permanently.

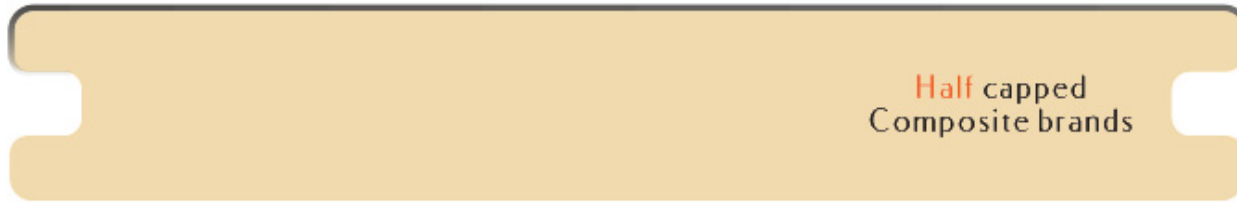
C

**A brand only capped top half of the board,  
this solves some problems, but other problems occur**

- Capping the top half of the board does provides higher stain & scratch resistant, and gives protection against UV from top so it helps to maintain the color in certain period of time.
- However, because the capped layer shield and inner core were made of different materials, so they have different expansion and contraction rate, and also more significantly in this case: the difference in water adsorption rate.

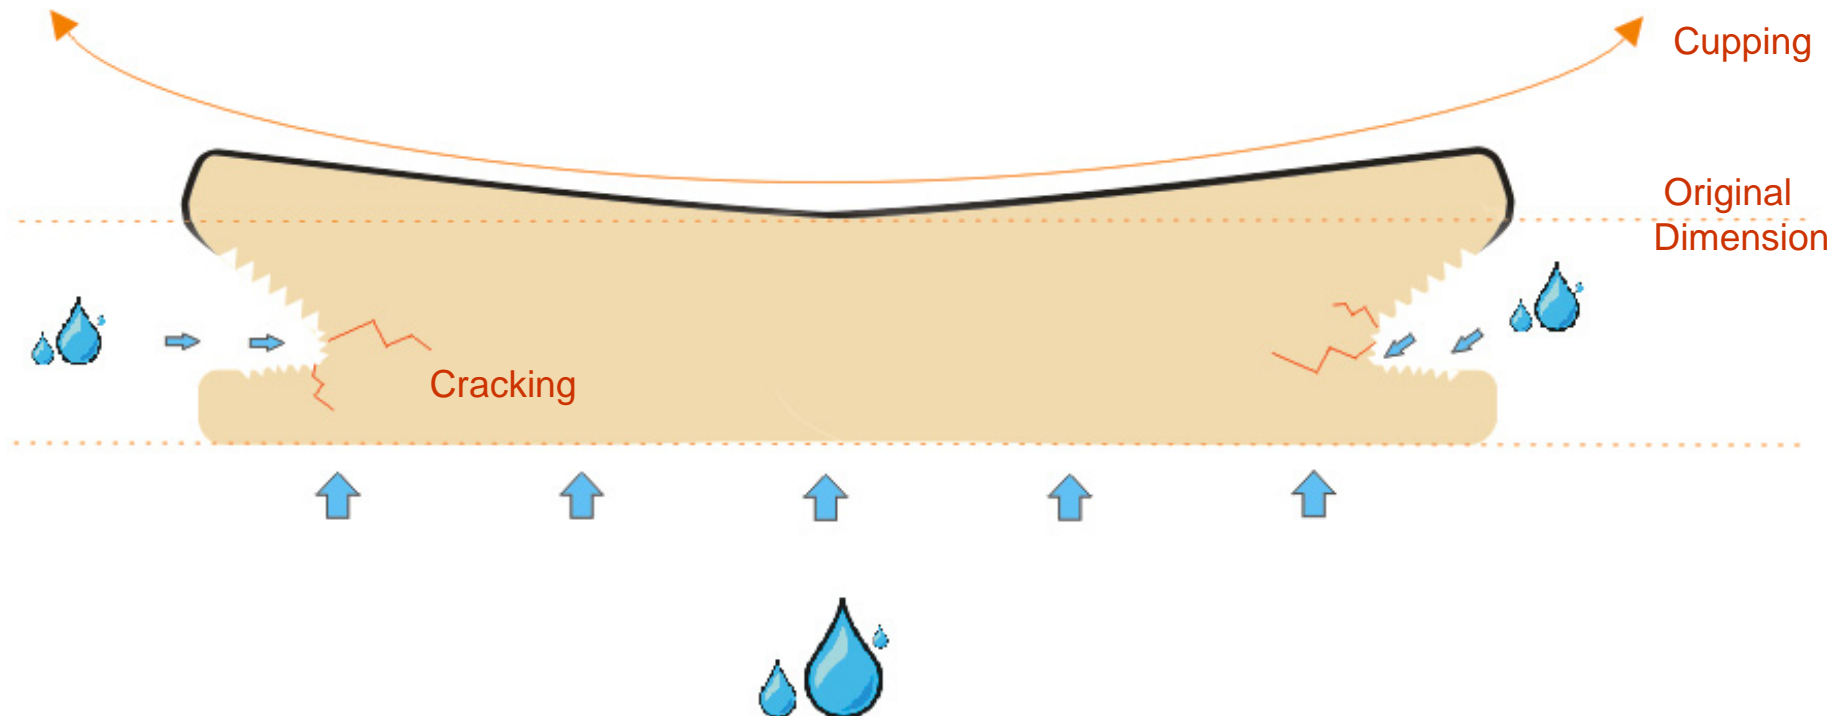
- The core swells and expands while the capped layer doesn't, in which it makes the board cupping and cracking apart in the groove.
- Cupping is the capped layer curving outward as shown in the diagram. When capped layer only covers the top side of the board, the force of contraction pulls the entire top layer from the bottom layer which is holding down by the clip. and causes cracking.

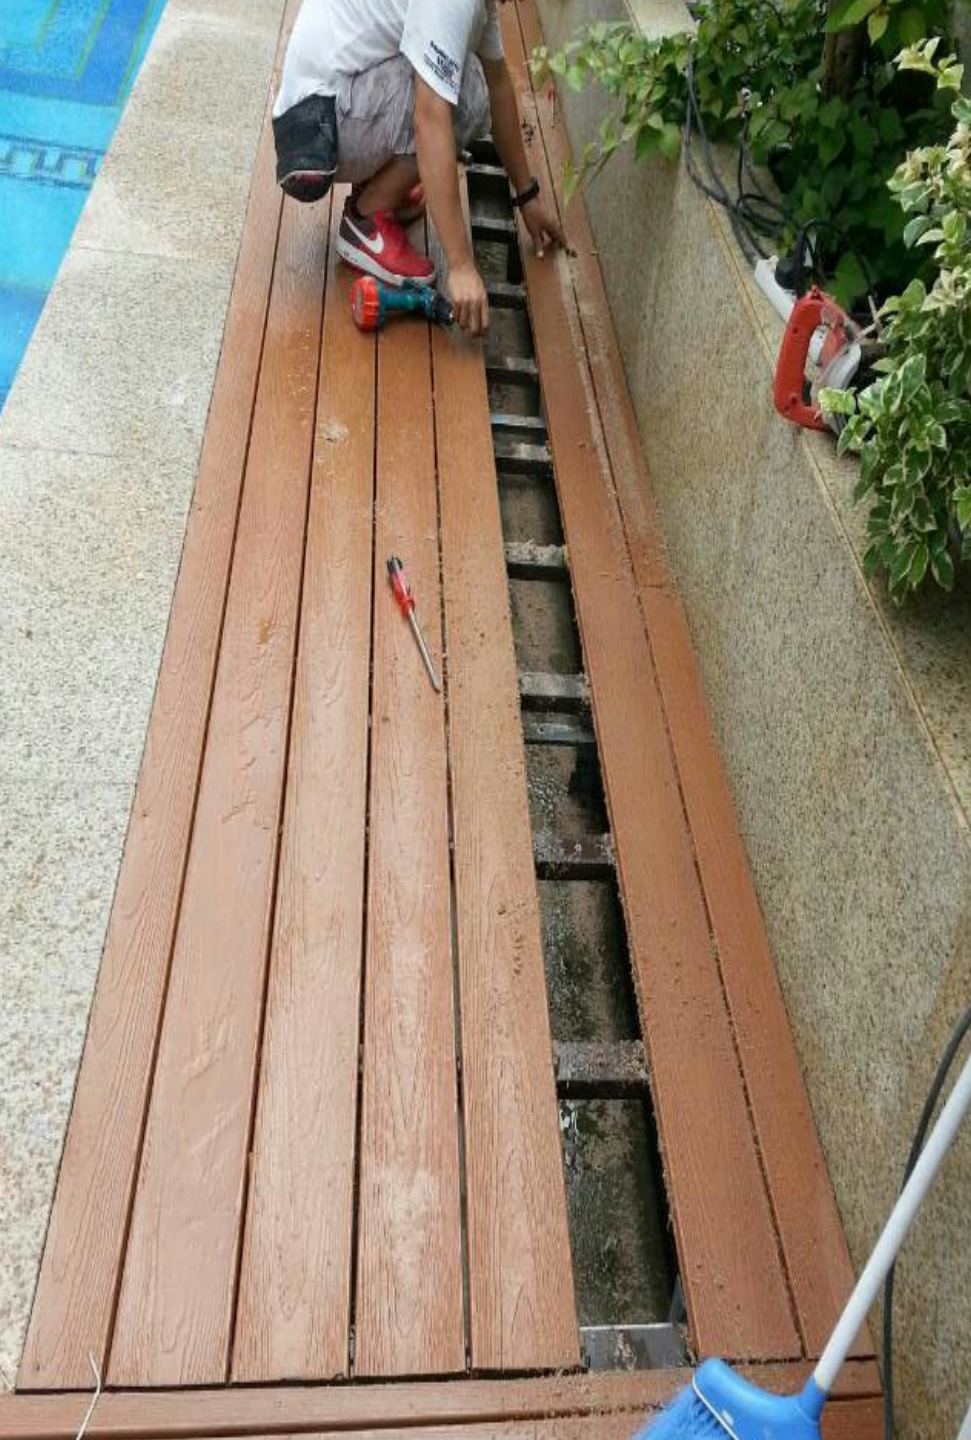
**Whole project were re installed**

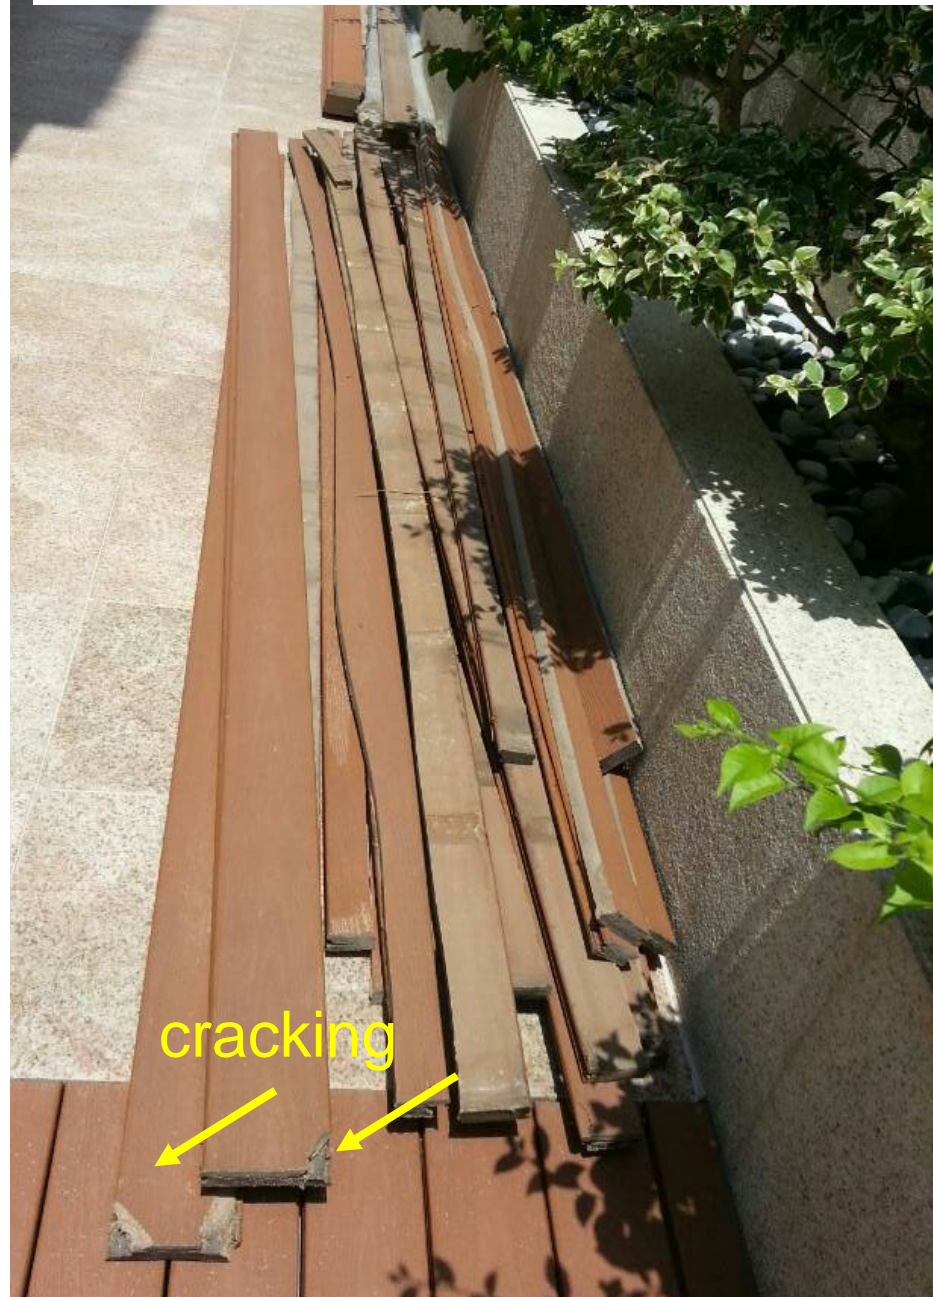
**Uninstalled deck boards**

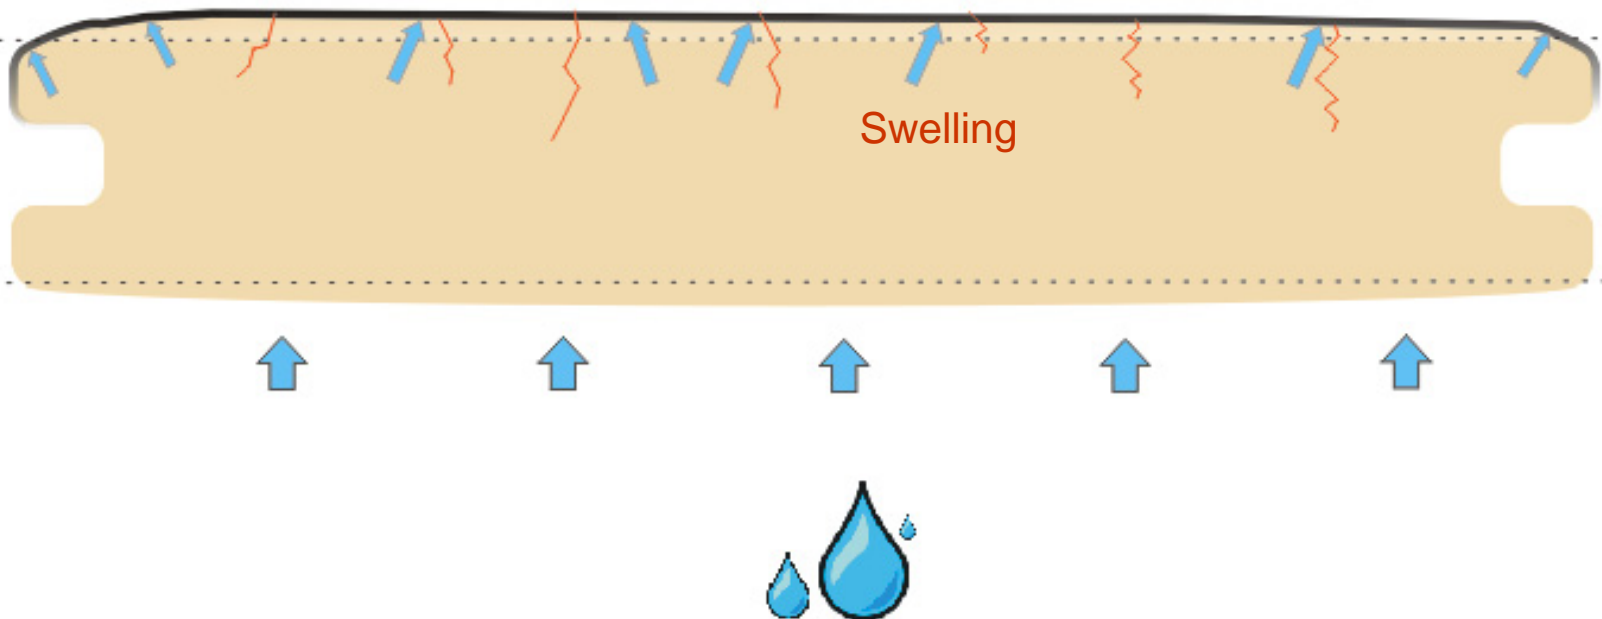
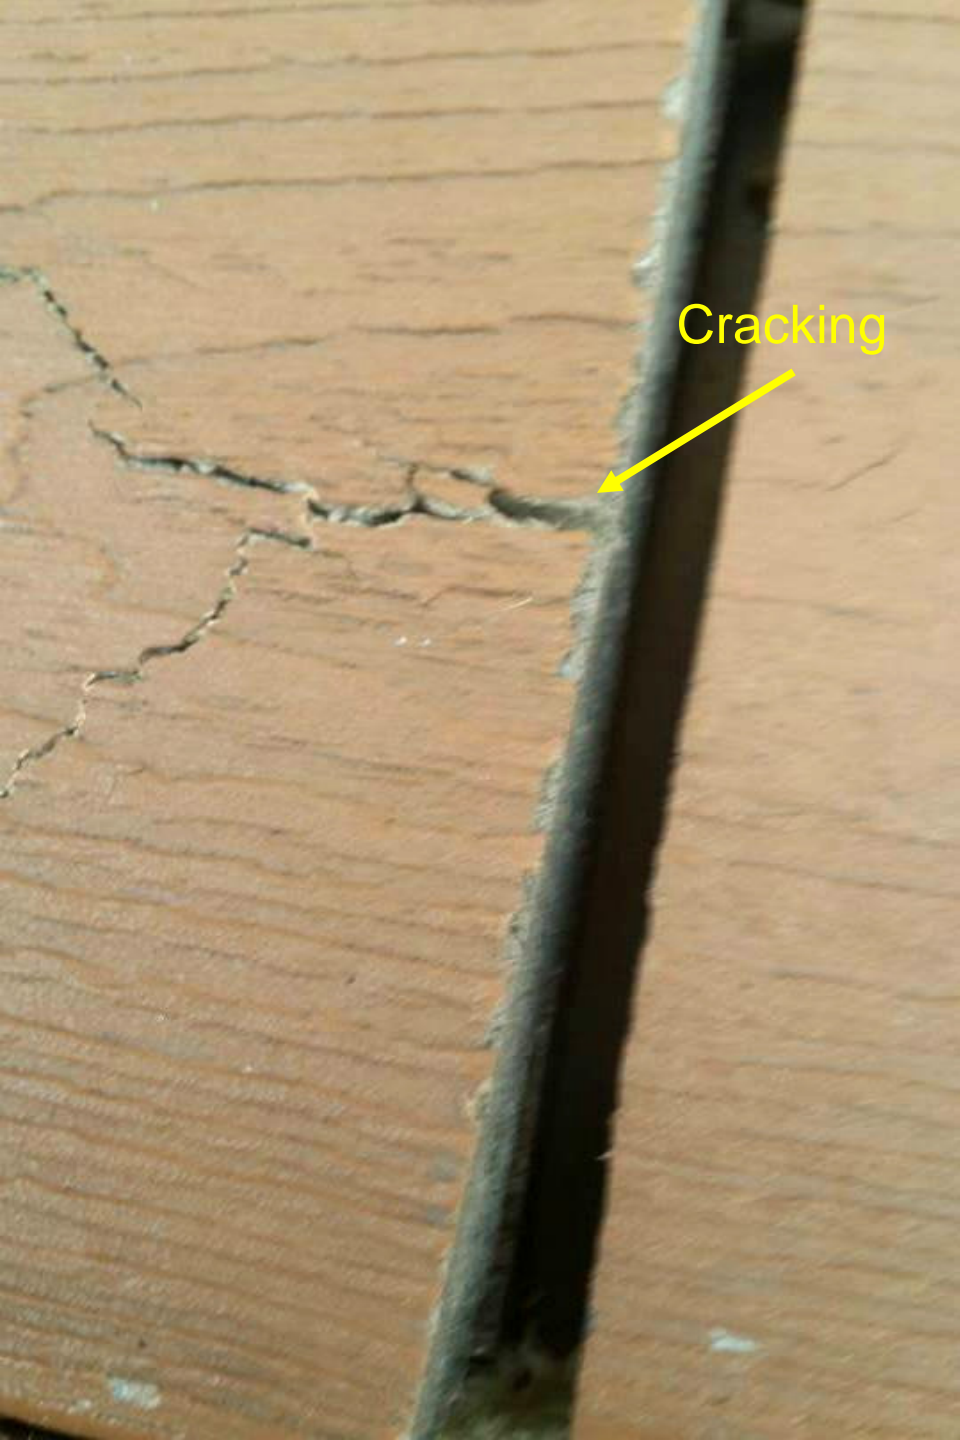
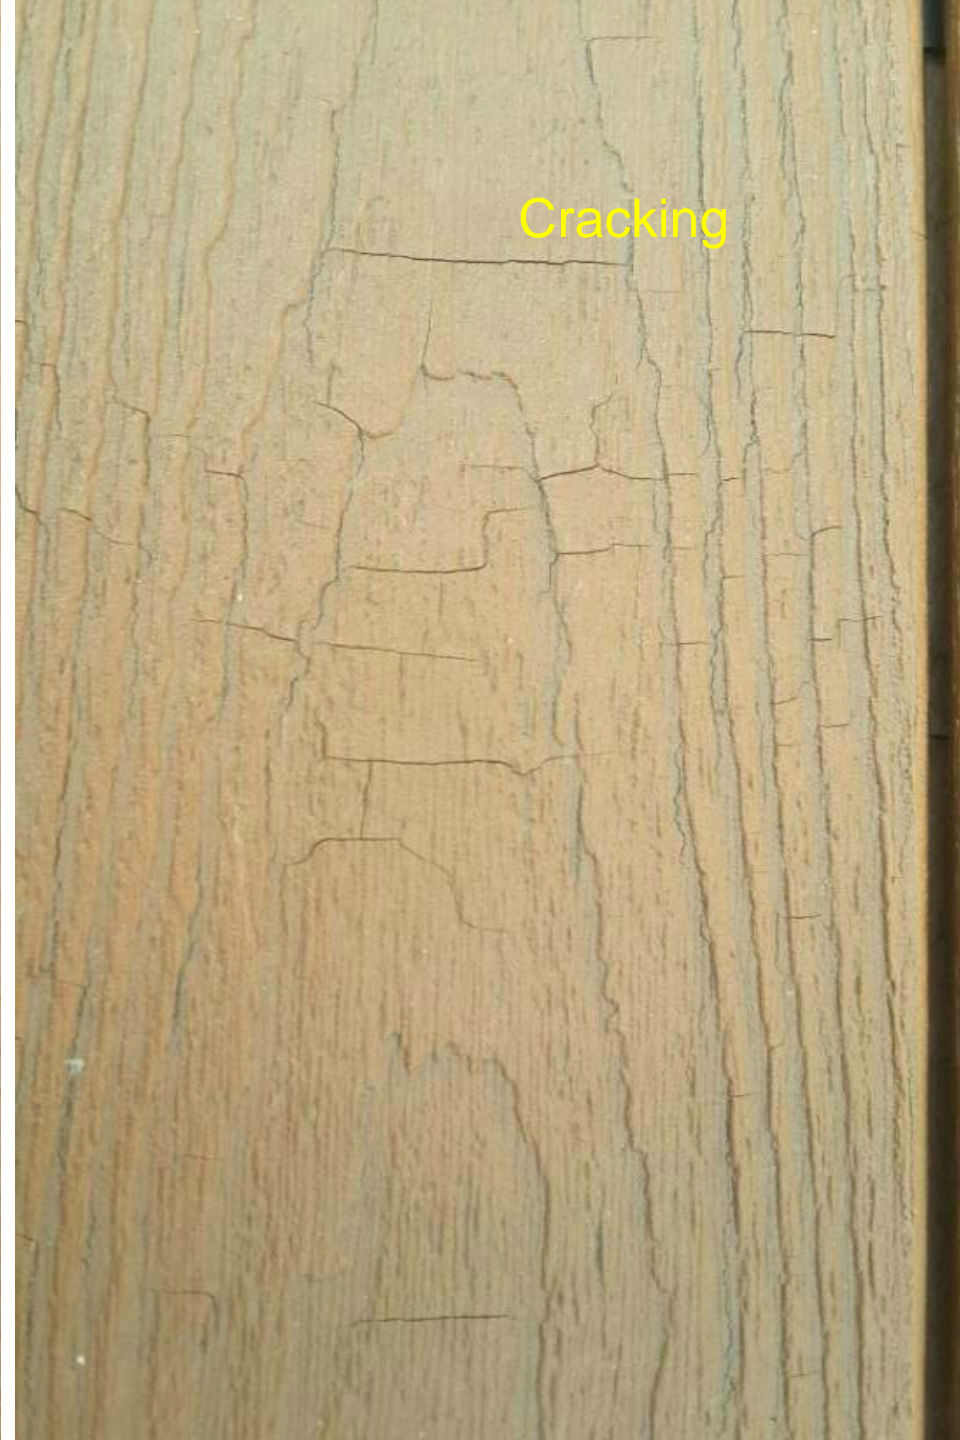
- Similarly, because the inner core swells and expands. The force push outward and crack the capped layer.

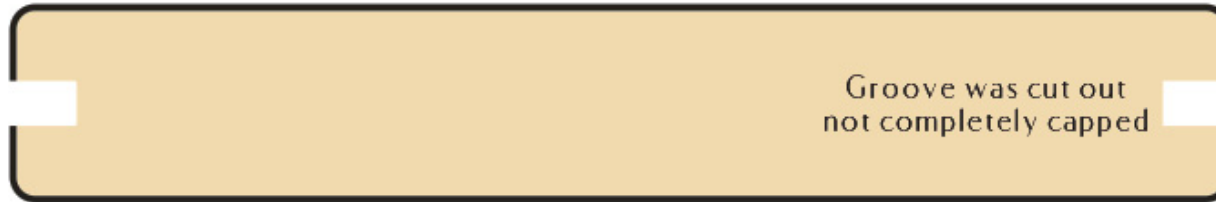
B

**Some brands have boards with uncapped groove, by cutting out the groove on both sides of the board, or were unable capped technically.**

- With uncapped groove, the moisture can still go into the core from the groove along the entire board, so the swelling, cupping and cracking hazards are still potentially existing
- During the groove cutting, the capped layer could be damaged.

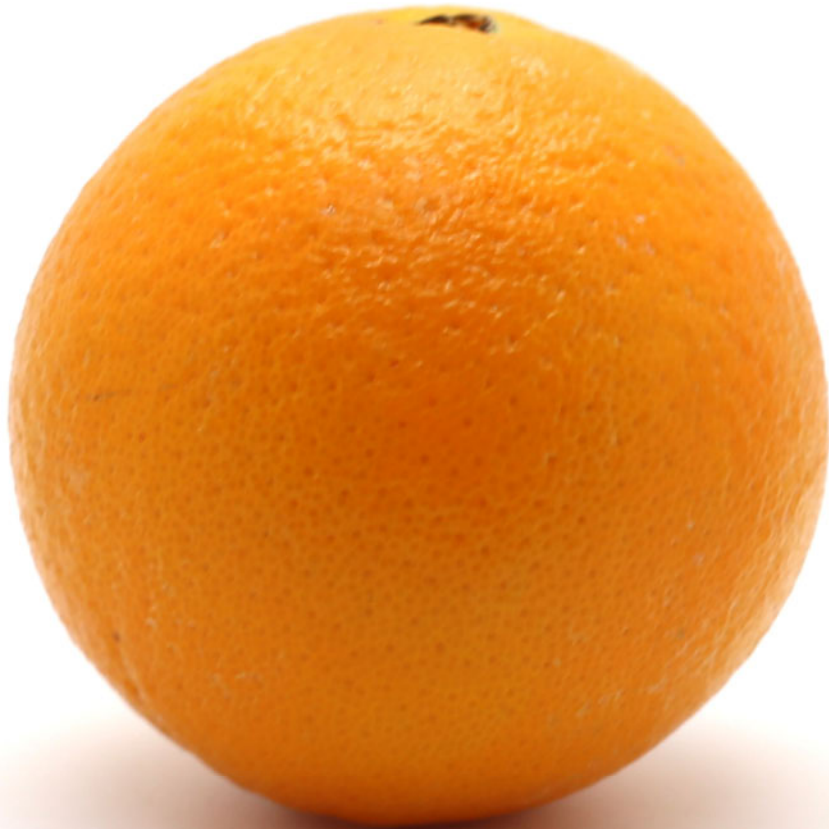
Full Skin  
→ 360 degree Completely Capped

**UltraShield®** has 360 degree complete protection all around the board including tiny area of curvature and groove area.

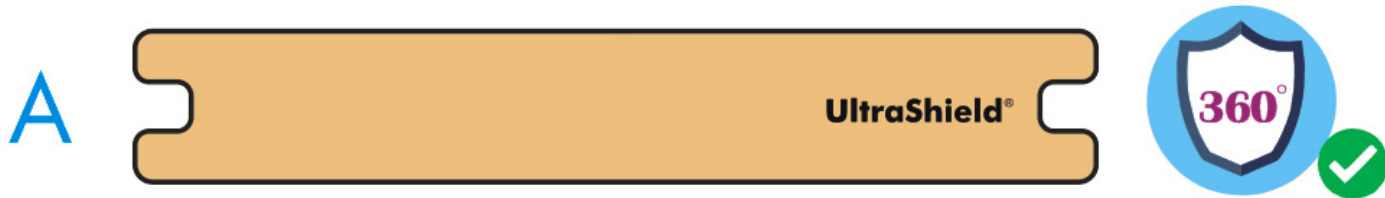
**UltraShield®** believes this is the only way to protect the board from UV, water, insects and any other bacteria attacking the core.

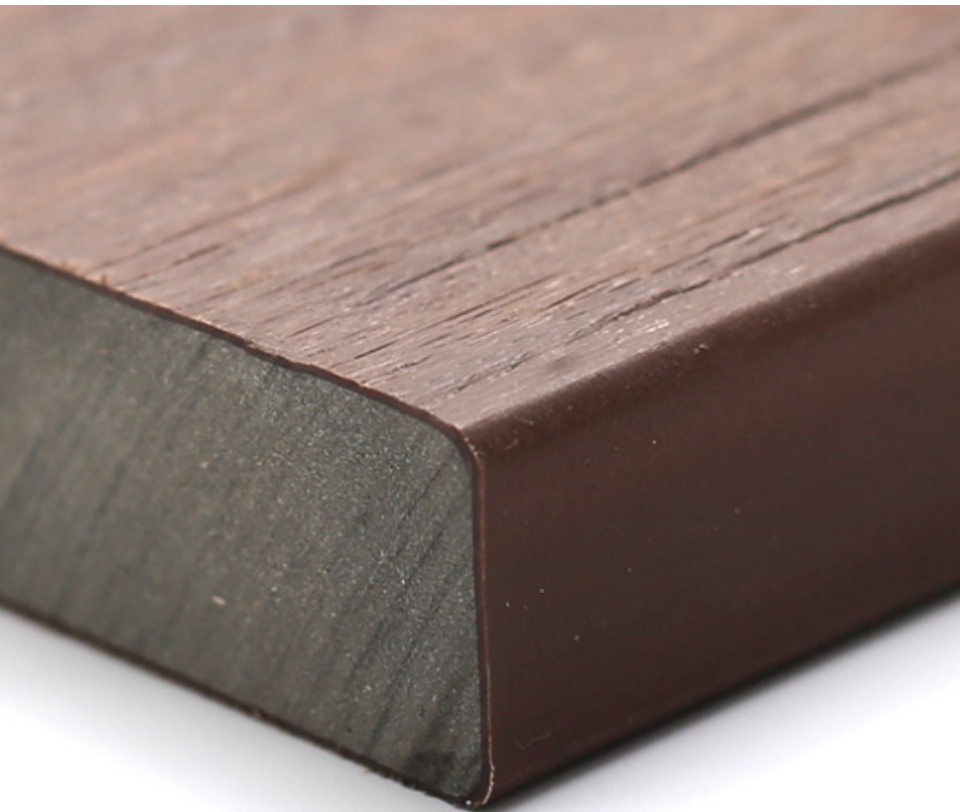
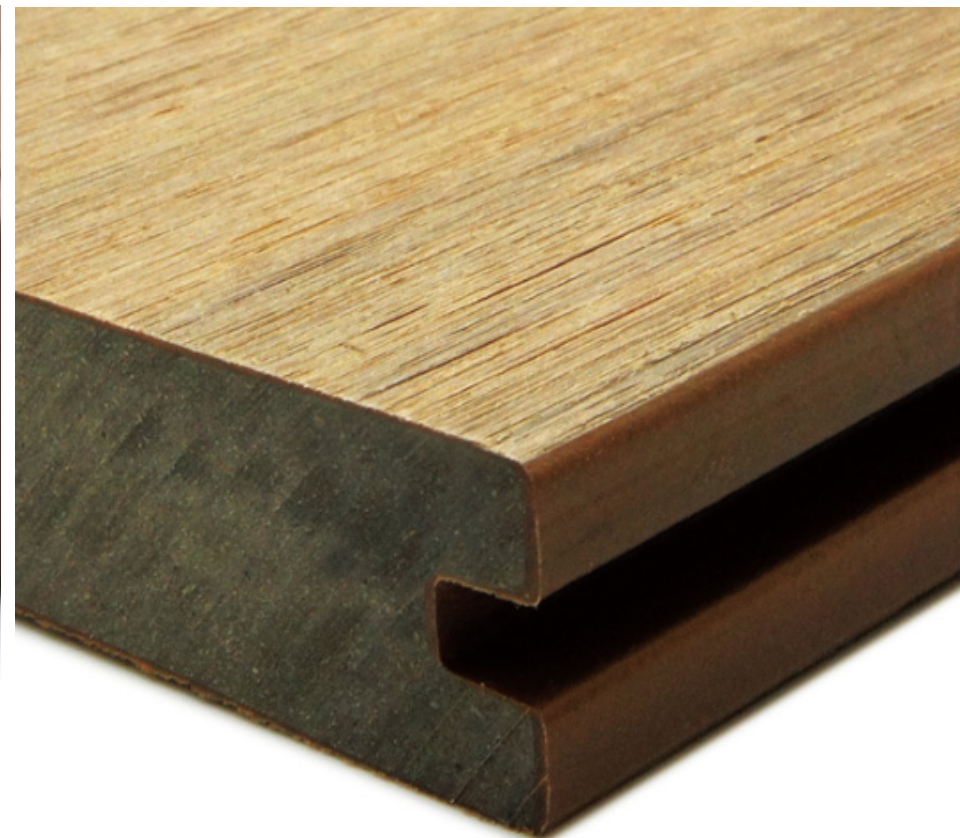
has a strong & durable polymer shield capped the core 360 degree.

- **The Core** is made of wood fiber, PE polymer and additives .
- **The Shield** is made of special engineering grade polymer and additives with extreme low water penetration.

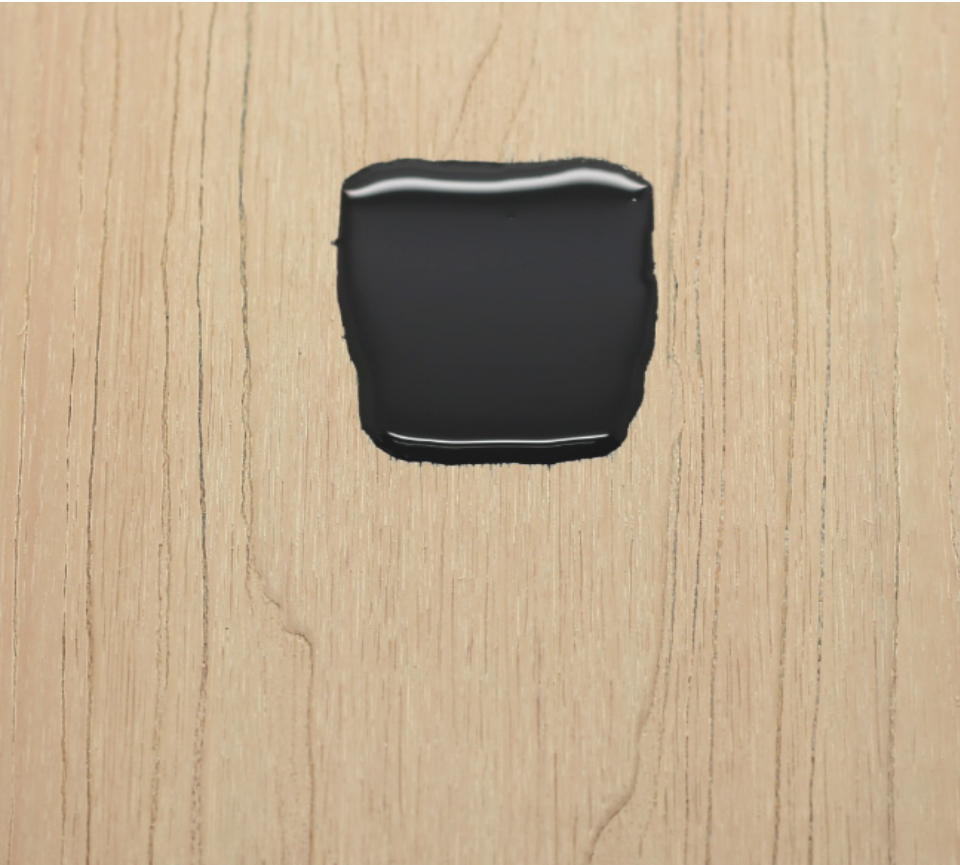
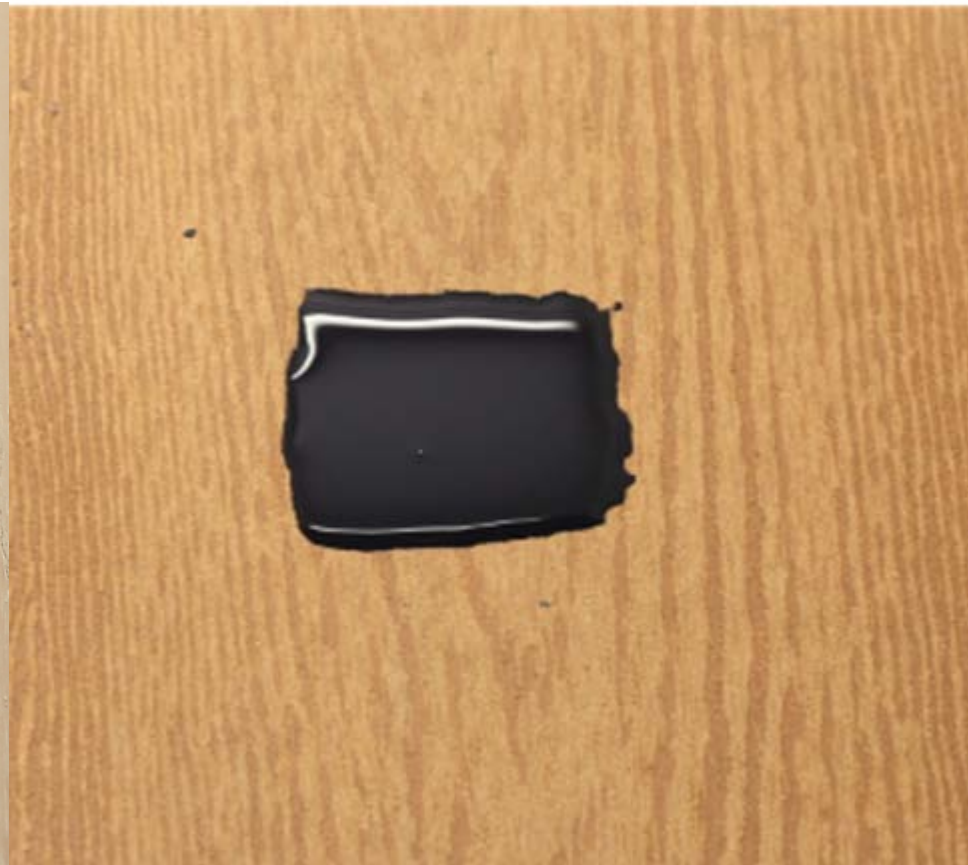
Step 1. Stain with black ink

UltraShield decking

Conventional decking

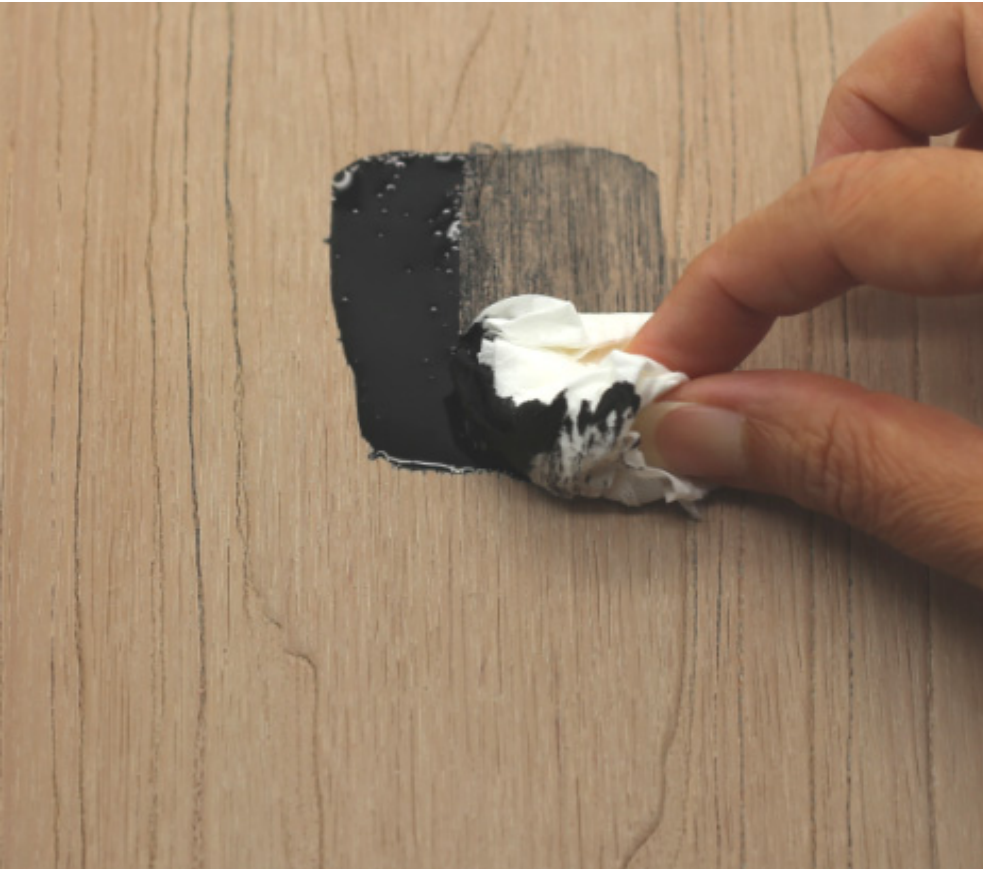
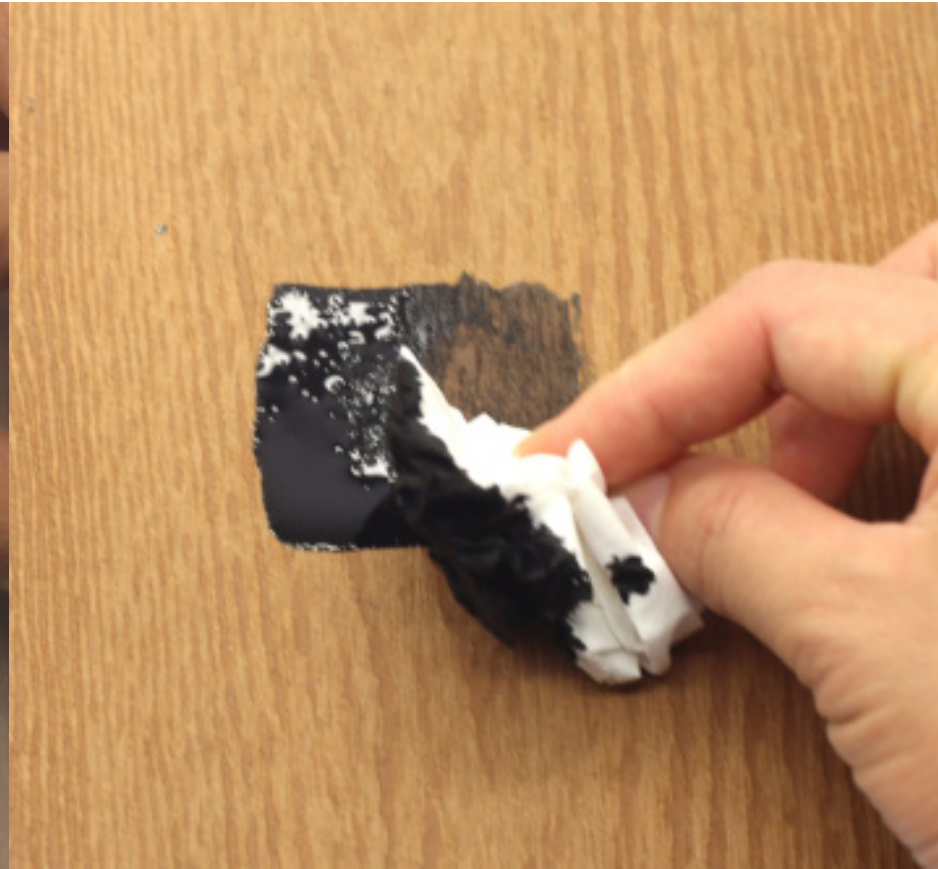
Step 2. Wipe out half of the ink

UltraShield decking

Conventional decking

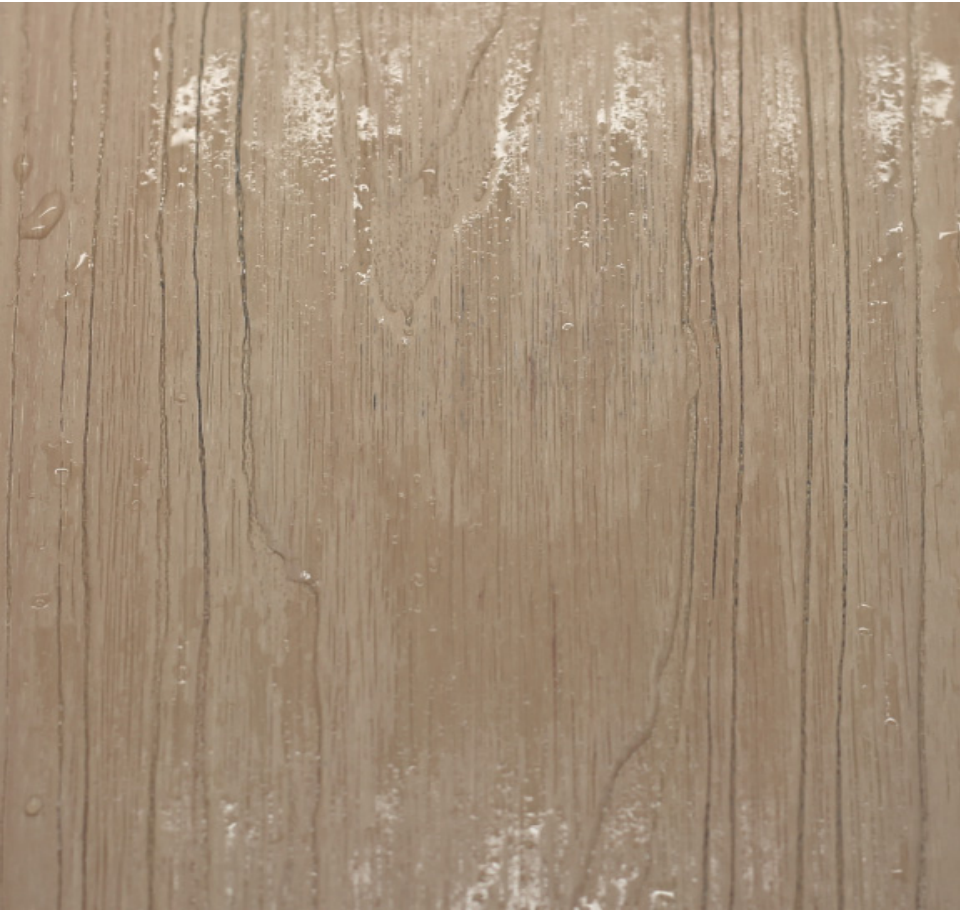
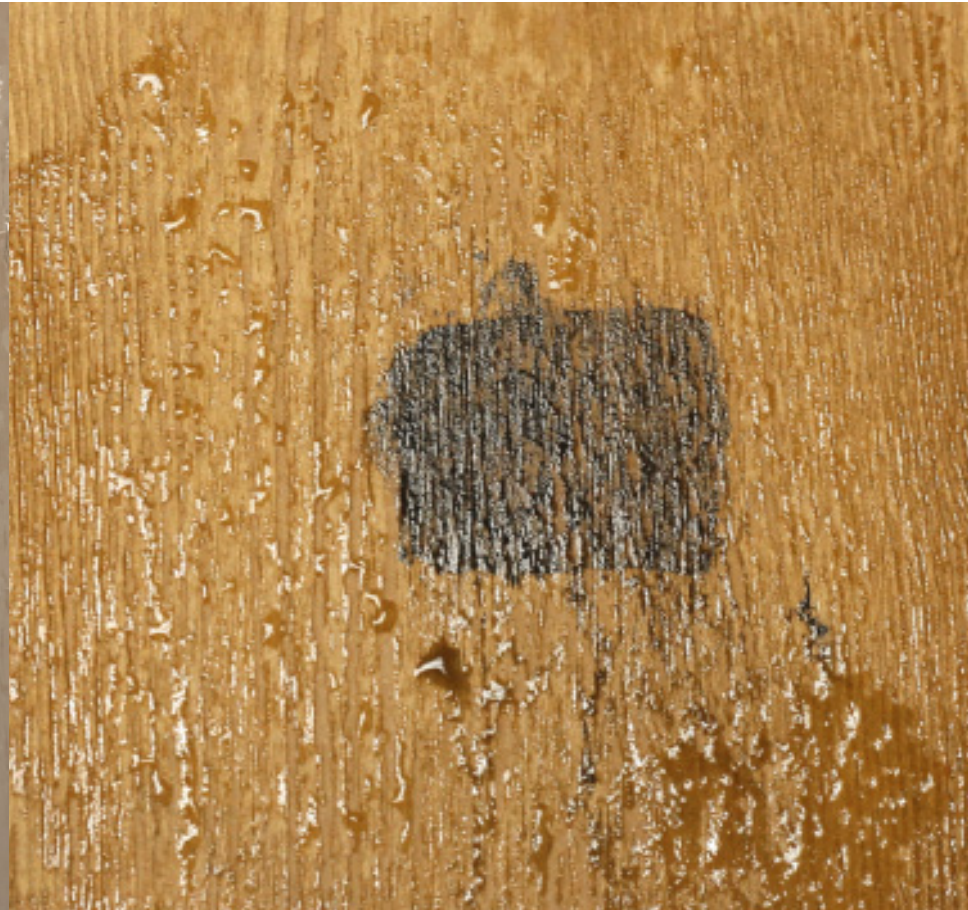
Step 3. Wash off by water

UltraShield decking

Conventional decking

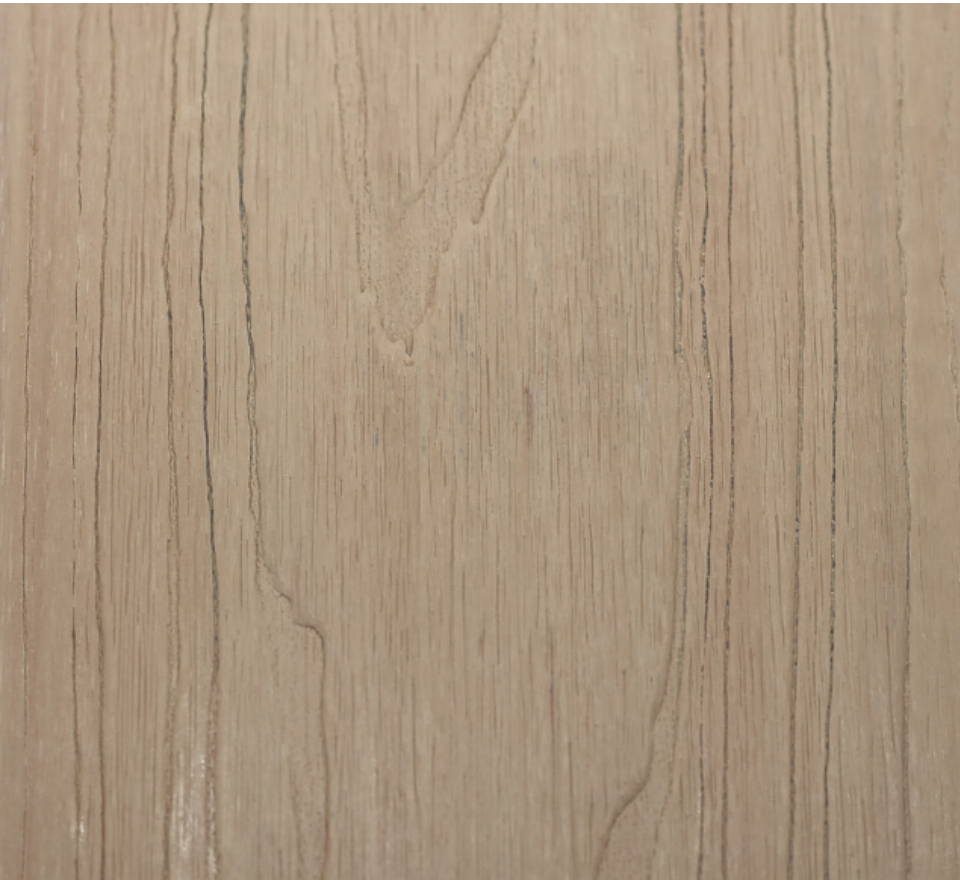
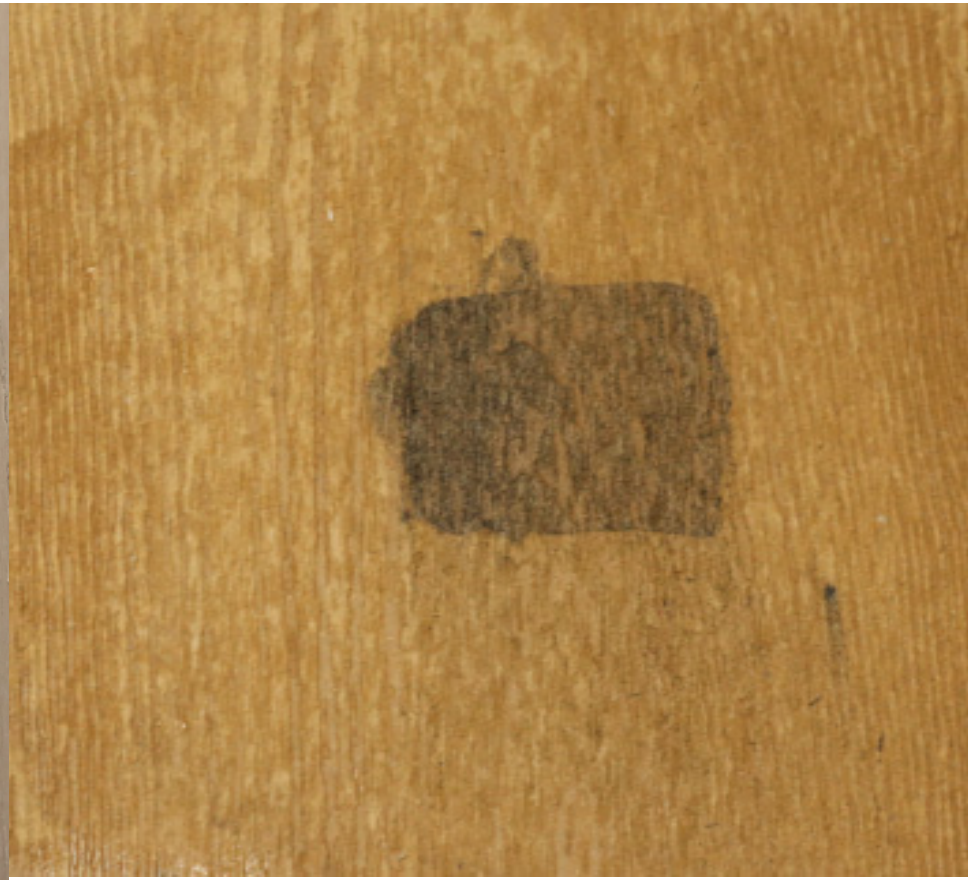
Last Step: Dry and see the result

UltraShield decking  
No penetration through the top  
layer and no stain left

Conventional decking  
Stain remains
