# Why UltraShield®?

# UltraShield®

# UltraShield® Advanced Capped Composite Material

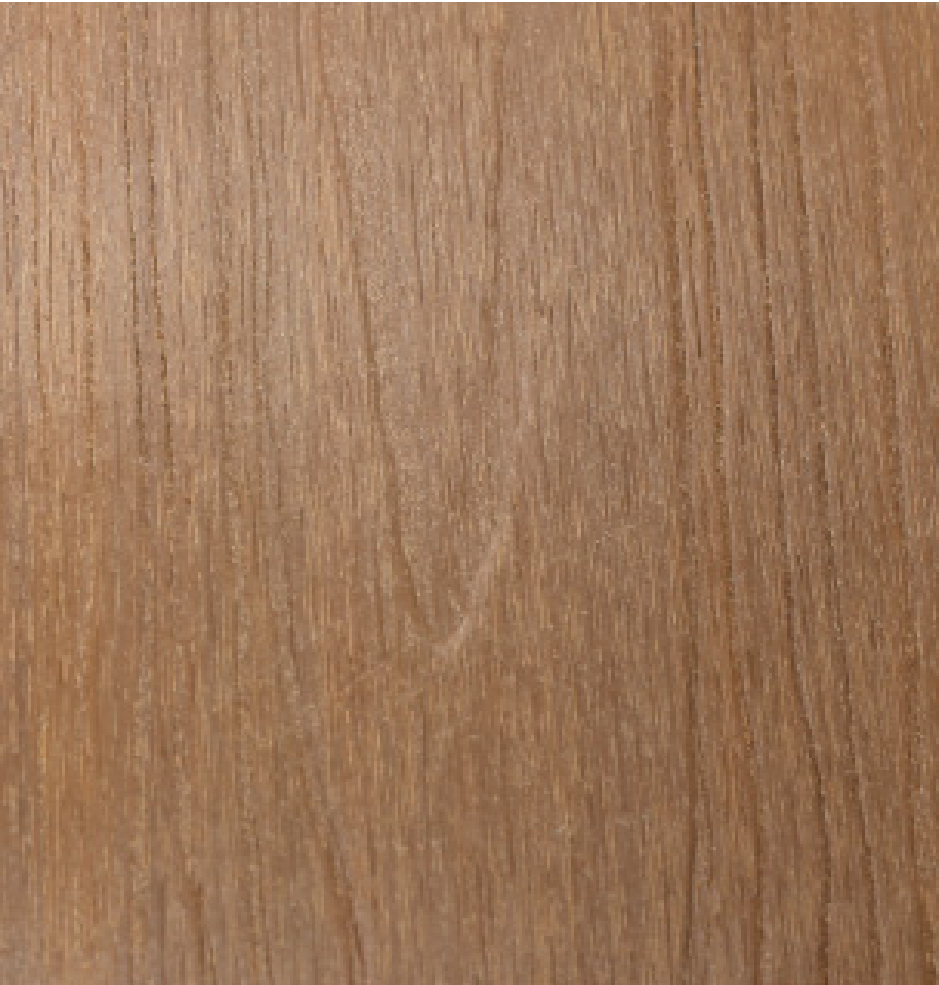
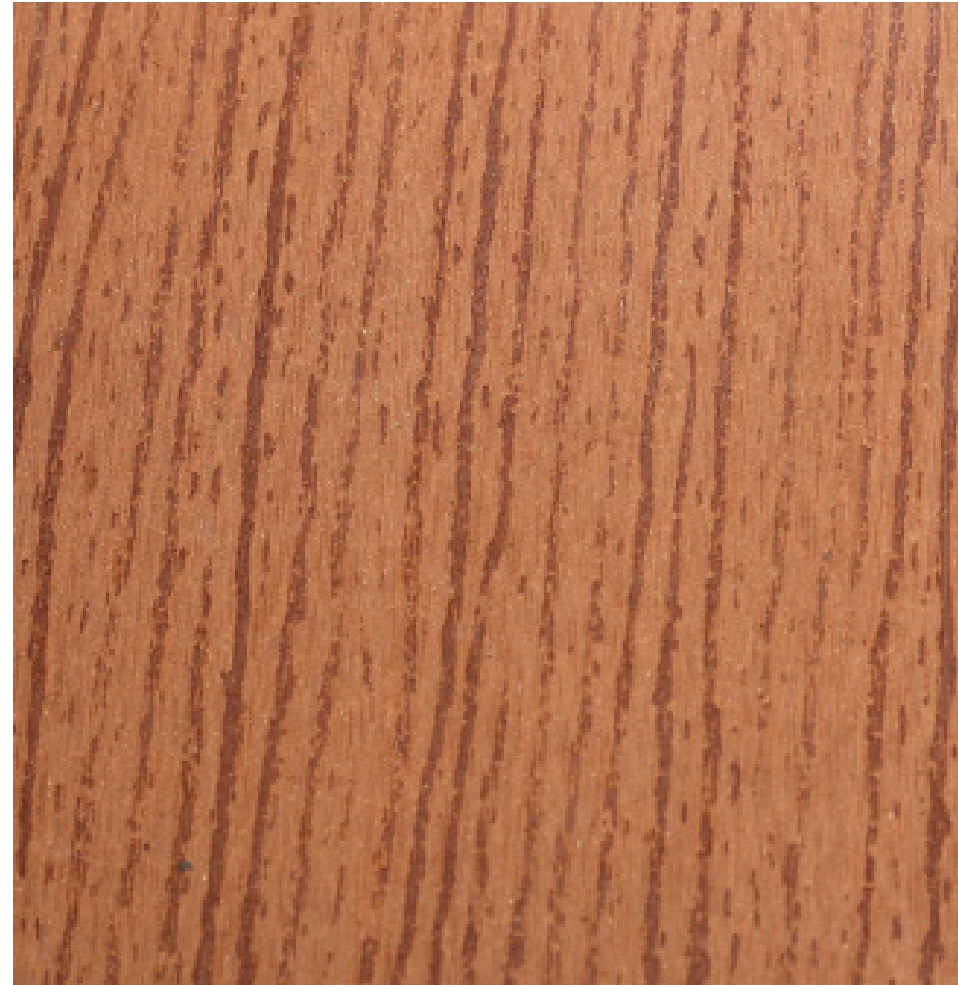
Original surface of the boards

UltraShield decking

Conventional decking

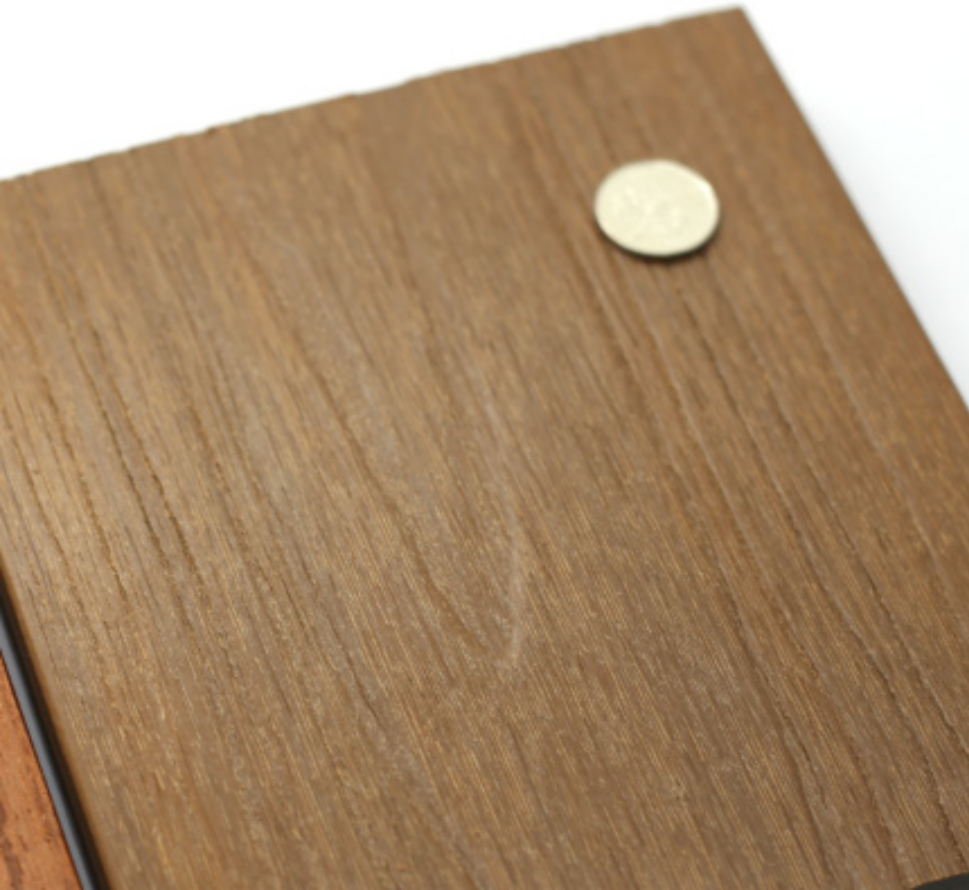
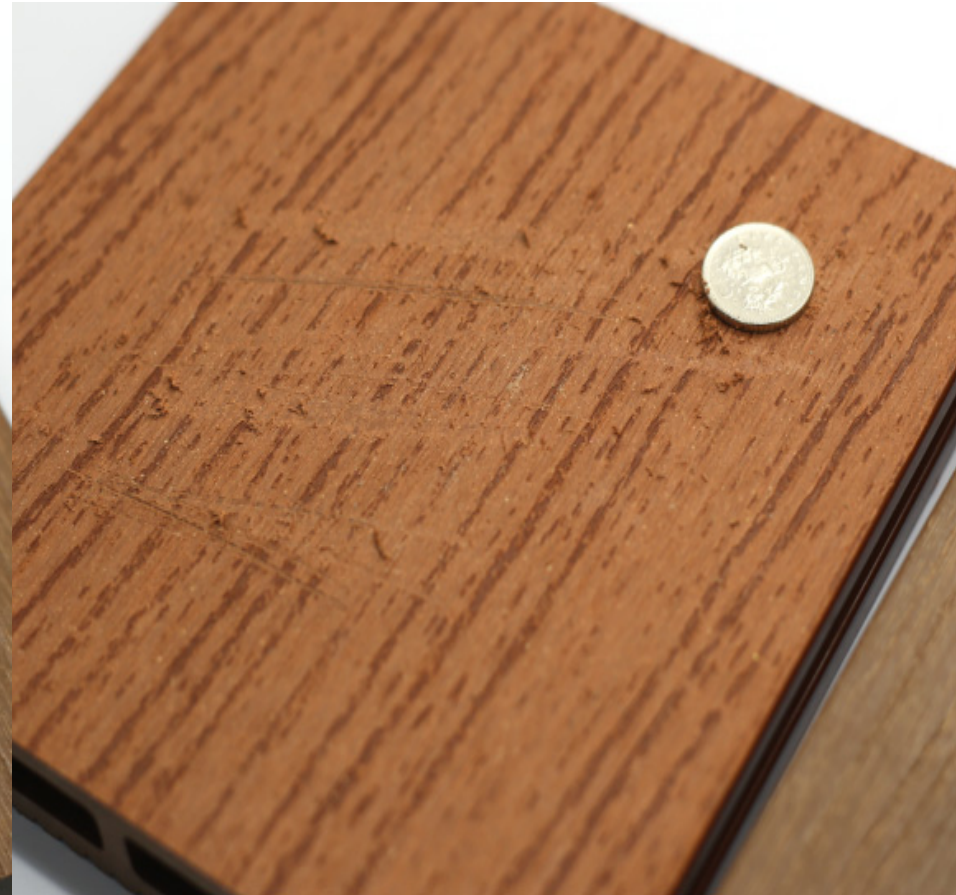
Scratch with coin

UltraShield decking  
Insignificant marks

Conventional decking  
Significant marks & material worn off

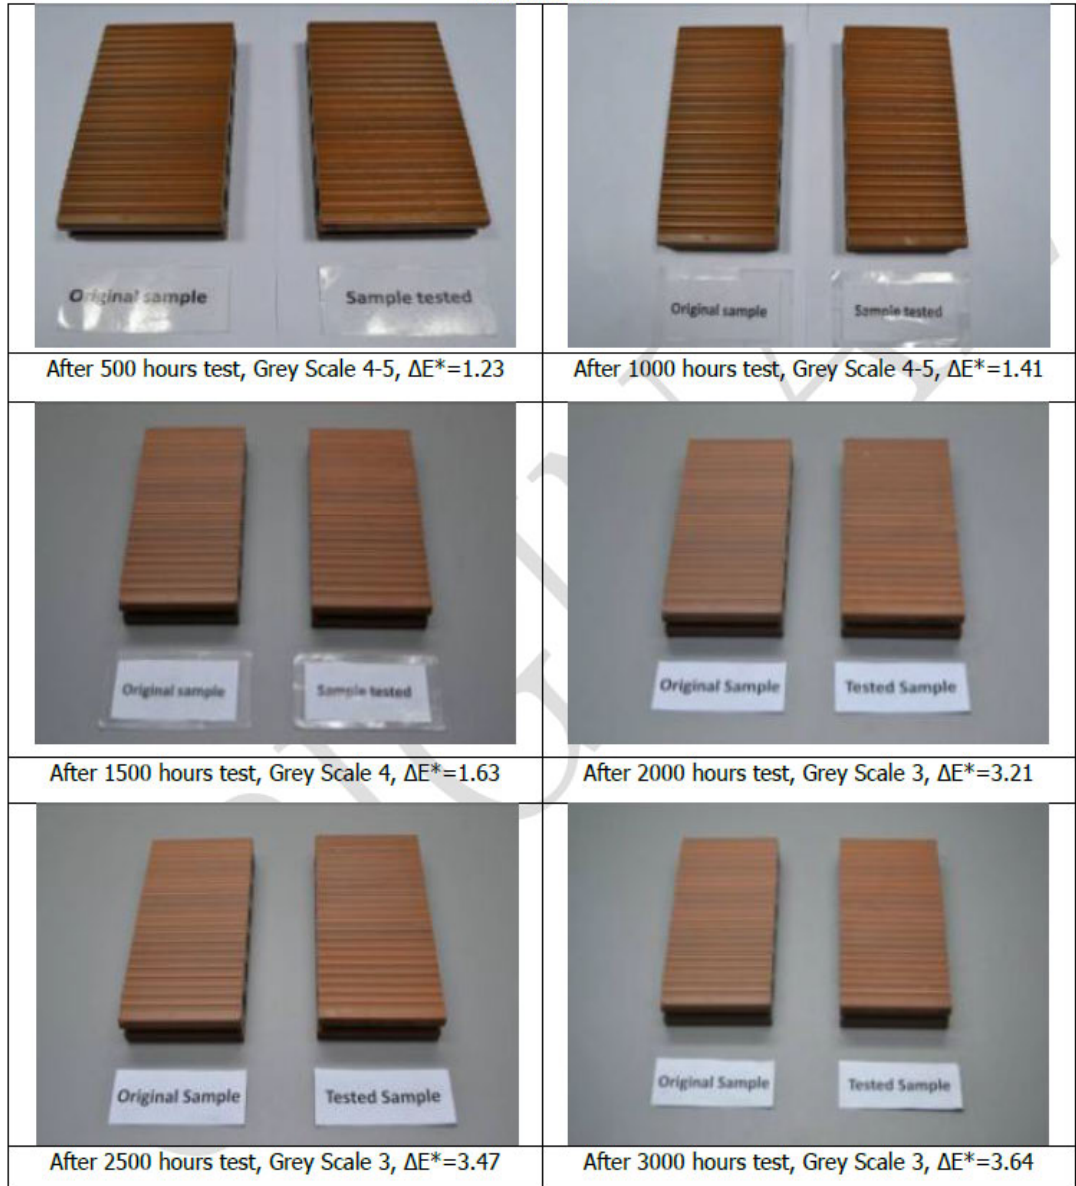
Model: UH07

Tested in a QUV chamber for 3000 hours, no visible color change can be observed  
(Delta E <4.0)
